TECHNICAL COMMITTEEMEMORANDUM TCM 09/01

Beal rope, snapped
Incident Ref. 09/01/B.HEU

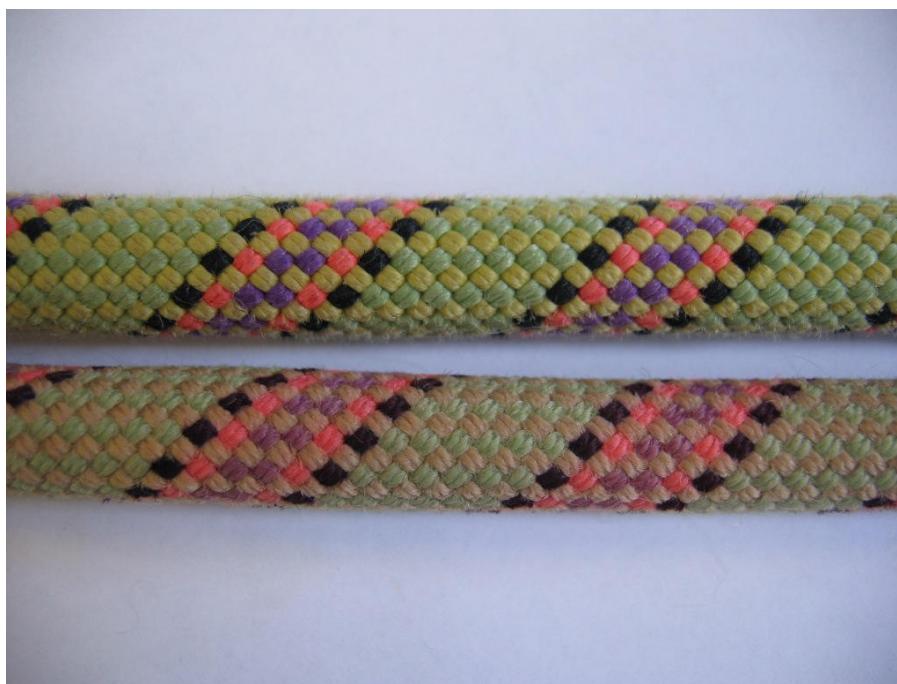
A visual and tactile inspection of the rope found numerous areas of discolouration of the sheath. The texture of the sheath material felt noticeably different in the stained areas. Apart from the staining and odd texture, the rope appeared to be in good condition, with very little evidence of abrasion or scoring to the sheath.

Comparison of two areas of the rope sheath, showing discolouration.

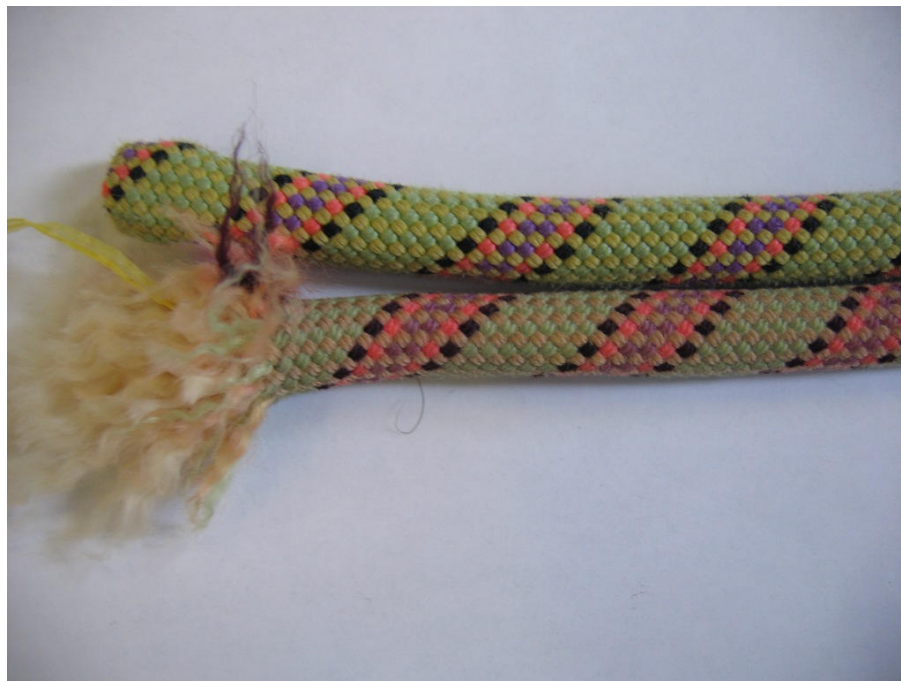
Inspection of the area where the rope had snapped found that the sheath was badly stained in this area. The break itself had occurred over a fairly localised area. The ruptured core strands appeared to be stained a yellow colour. Around the break, some of the exposed core strands could be pulled apart easily by hand.

Discolouration around the area of the break.

The rope snapped because of degradation of the polyamide material used in its construction. This degradation was caused by contamination of the rope by a strong acid from an unknown source. This incident could have been avoided if the rope had not been contaminated in the first place, but also if the user had been aware that the discolouration was caused by a dangerous chemical as opposed to chalk dust.

The owner and user of the rope should check that locations where the rope may have been stored or transported are not contaminated. The remaining 50m of rope should be inspected carefully for any evidence of discolouration and change in texture, and discarded if found to be present.
