**TECHNICAL COMMITTEEMEMORANDUM TCM 09/01**

**Beal rope, snapped**  
Incident Ref. 09/01/B.HEU

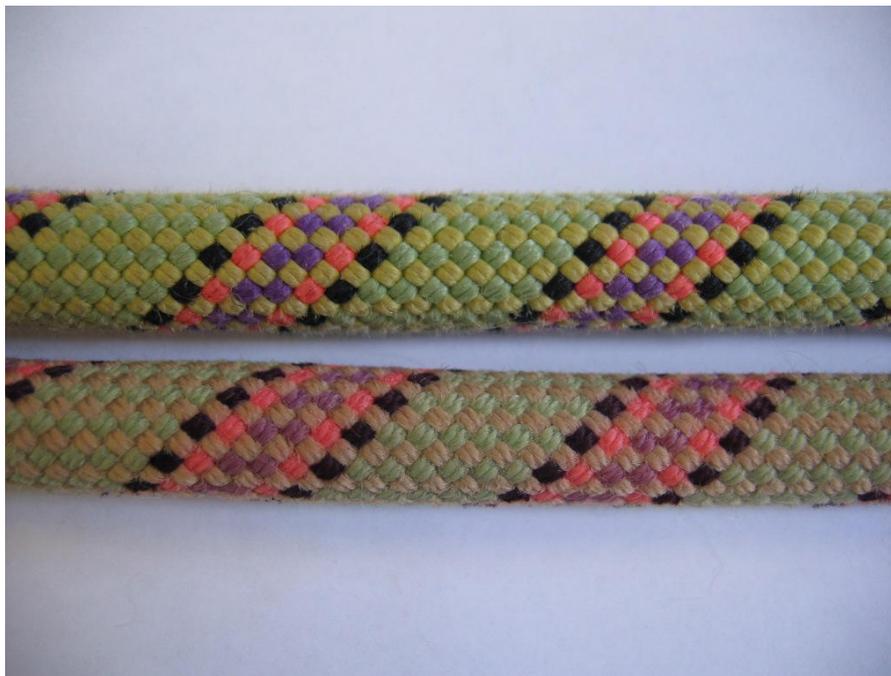
A visual and tactile inspection of the rope found numerous areas of discolouration of the sheath. The texture of the sheath material felt noticeably different in the stained areas. Apart from the staining and odd texture, the rope appeared to be in good condition, with very little evidence of abrasion or scoring to the sheath.

Comparison of two areas of the rope sheath, showing discolouration.

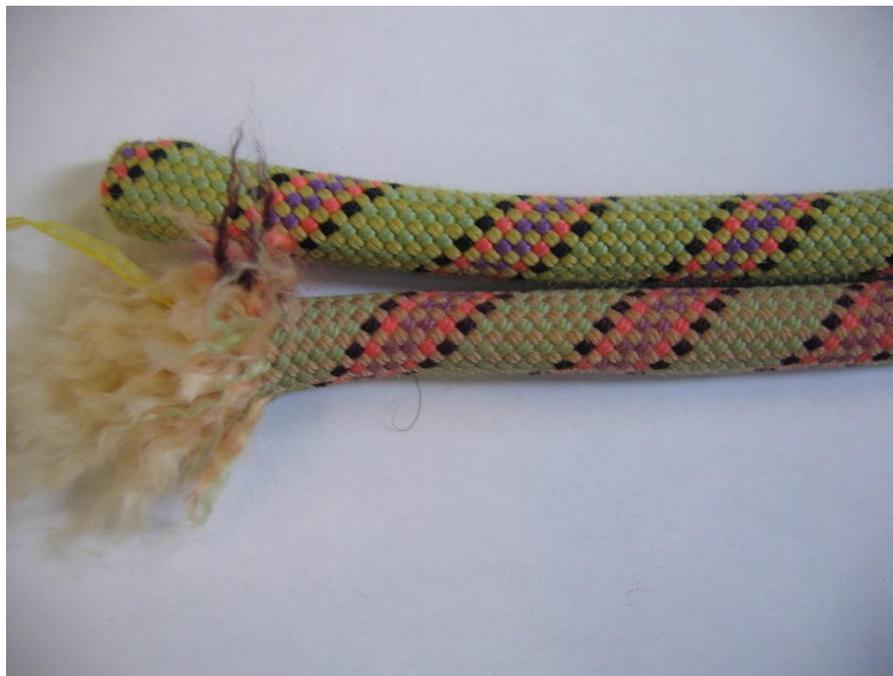
Inspection of the area where the rope had snapped found that the sheath was badly stained in this area. The break itself had occurred over a fairly localised area. The ruptured core strands appeared to be stained a yellow colour. Around the break, some of the exposed core strands could be pulled apart easily by hand.

Discolouration around the area of the break.

Before the rope was soaked in the water, the pH = 7 indicating a neutral solution. After soaking the rope, the pH = 2 which indicates an acidic solution, typical of a dilute concentration of a strong acid.

The rope snapped because of degradation of the polyamide material used in its construction. This degradation was caused by contamination of the rope by a strong acid from an unknown source. This incident could have been avoided if the rope had not been contaminated in the first place, but also if the user had been aware that the discolouration was caused by a dangerous chemical as opposed to chalk dust.

The owner and user of the rope should check that locations where the rope may have been stored or transported are not contaminated. The remaining 50m of rope should be inspected carefully for any evidence of discolouration and change in texture, and discarded if found to be present.
