BRITISH MOUNTAINEERING COUNCIL

TECHNICAL COMMITTEE MEMORANDUM TCM 10/04

DMM Ascent helmet, Head injury

Incident Ref. 08/10/F.KIN

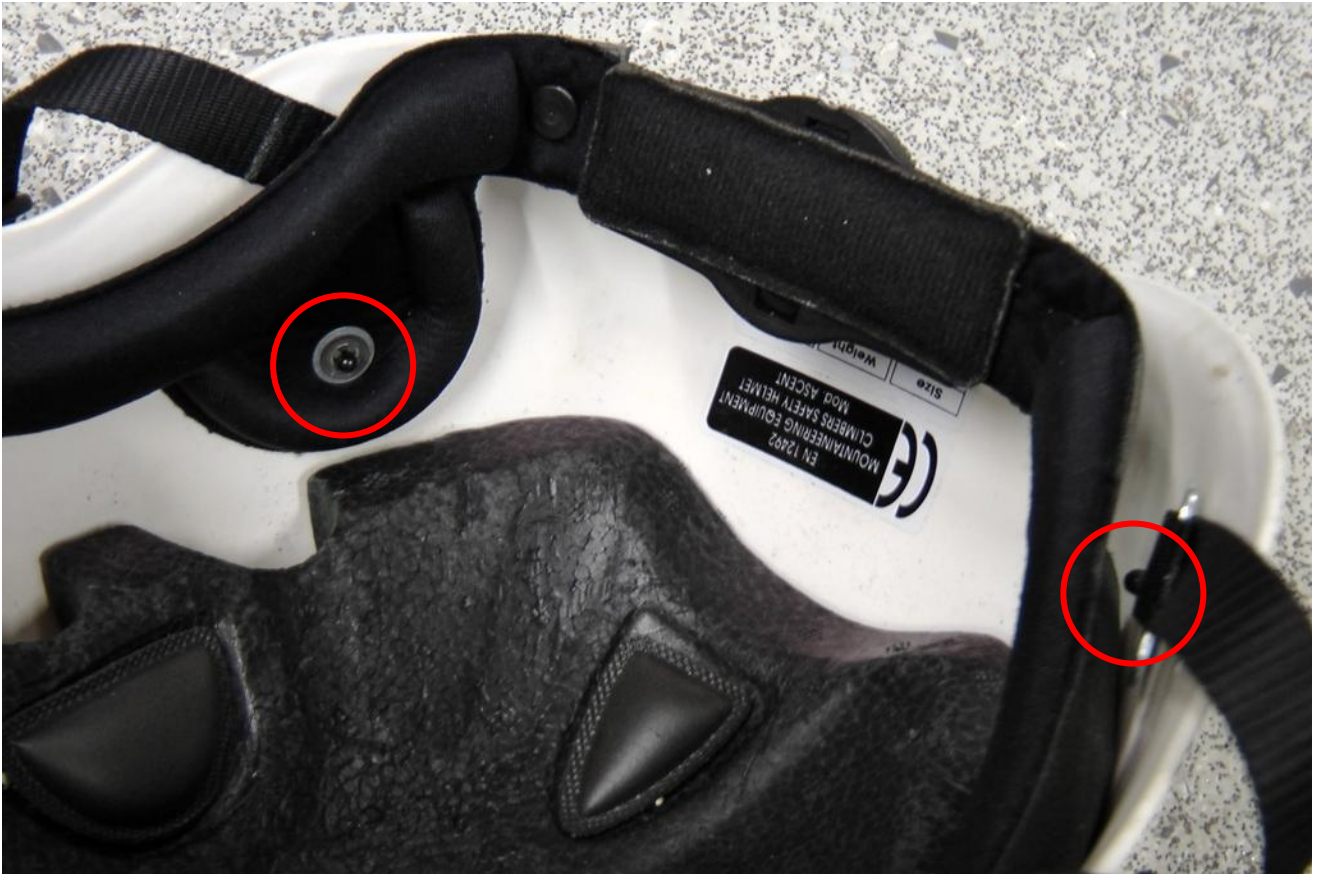
Fig 1. Internal rivet location

The helmet is of hybrid construction, consisting of a relatively stiff plastic shell and an expanded foam liner. Four identical plastic mouldings act as headlamp clips on the exterior of the shell, each secured on the inside of the shell with two attachment points. These attachment points are additionally used to secure both an interior adjustable head cradle, and the chinstrap system. A photo of their location was taken. [Fig 1]

Examination of the 8 attachment points found that they have a small and almost hemispherical profile protruding into the interior of the helmet. To protect the head, four of the attachment points are covered by a layer of plastic backed foam which forms part of the interior cradle. The remaining four points have a semicircle of soft foam padding surrounding them.

The big surprise here was that there were no noticeable indentations left by the 8 obvious rivets. Further inspection gave a possible explanation for this. The four highest rivets are located close to the edge of the foam liner. Unless this liner is significantly compressed, then these rivets are unlikely to contact the head. The four lowest rivets are covered by a plastic sheet and soft foam. Whilst it seems logical to assume that under a major impact that this soft foam might compress and allow

one of these rivets to contact the head, this was not noted in our simulation which involved moderate impacts.

The BMC should remind climbers to choose the correct size of helmet, and to ensure it is a good fit for the user. The helmet manufacturer should consider improving the design of this particular helmet, even though there is nothing to suggest that it does not meet the required EN standard. Encouragingly, DMM have already stated that they will do this as part of their Quality Management system.^[1]

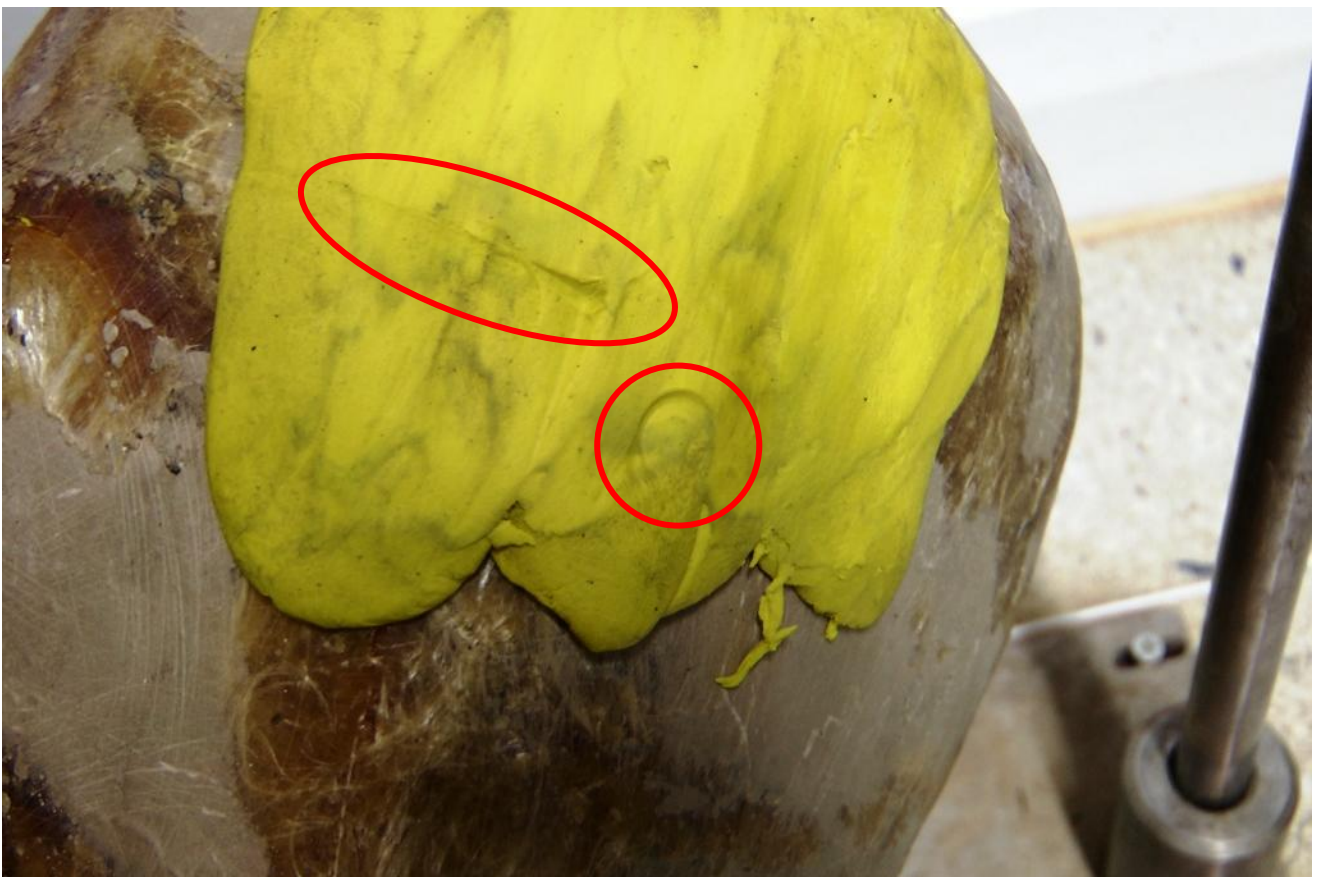
Fig 2. Marks left after the plasticine test

A standard medium test headform had a thin patch of plasticene applied, the helmet was placed on top and the helmet was struck using a handheld hemispherical striker. The striking target was the right rear of the shell where scuffing had been noted. The severity of these blows could be characterised as moderate. The plasticene was inspected for any indentations. This test was repeated twice and photographs of the plasticene were taken. [Fig 2]

Noticeable indentations were left by two parts of the cradle system. The culprits were the plastic backing plate of the adjustment wheel, and a flat plastic rivet close to this, which allows the plate to articulate. Flexing the shell demonstrated that during impacts to the rear of the shell, the shell probably deforms and pushes these parts into the head. Inspection of several other different helmets indicate that they may also allow injury in a similar manner.
