## TECHNICAL COMMITTEE MEMORANDUM TCM 08/03

### Broken DMM Pro Wire

Incident ref: 08/07/C.ORG

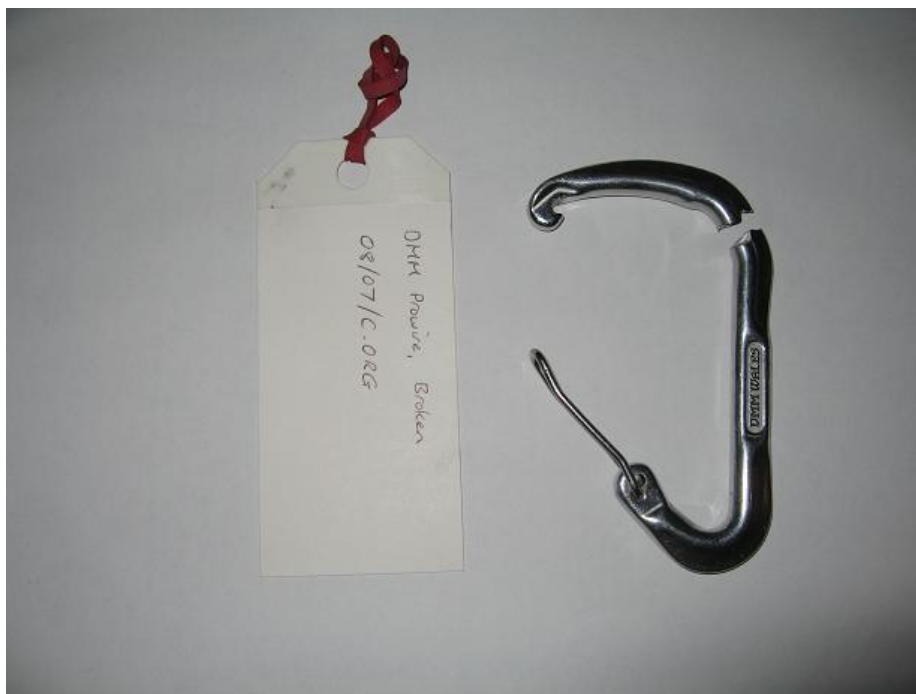
The broken karabiner has fractured in the curved section joining the spine to the top of the karabiner. There is considerable plastic deformation of the karabiner in this region such that if the two halves of the karabiner are placed together the nose of the karabiner is approximately 30 mm from the gate that would normally rest in it.

The fracture surfaces of the two broken halves of the karabiner exhibit a rough texture and show no indication of pre-existing cracks or corrosion.

The wired chock that the karabiner was clipped to before failure was also submitted for examination. The wire stop shows a slightly flattened surface with squared edges in the end of the wire stop that the karabiner would have been clipped into.

The marks in the wire stop of the chock into which the karabiner was clipped indicate that it was located in the nose of the karabiner when loaded. This would hold the gate of the karabiner open and result in a low failure load, less than 4 kN. A force exceeding this would easily be generated in a fall similar to that described in the climber's report<sup>3,4</sup>.

The karabiner failed due to being loaded close to its nose with the gate being held open. This was most likely caused by the wire stop of the protection chock being caught in the nose of the karabiner holding the gate of the open and loading the nose when the climber fell.

Climbers should be reminded to check that their protection is properly clipped when climbing to prevent this type of incident occurring. It is not known whether the wire could become lodged in the nose of the karabiner after being clipped.
