### TECHNICAL COMMITTEE MEMORANDUM TCM 09/02

#### Wild Country Technical Friend 3 - Broken in Fall Incident Ref. 08/09/L.HOU

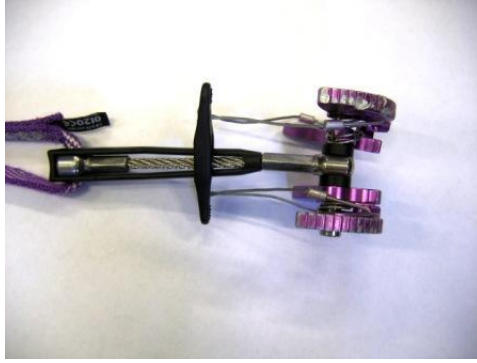
Fig 1

As can be seen on the photographs the stem of the Friend is bent (Figs 1 & 2) and one of the inner cams has sheared away from the axle (Figs 3 & 4). The surfaces of two of the cams are badly damaged (Figs 4 & 5) and all the trigger wires are bent. From an examination of the undamaged stem and the tape sling it appears that the Friend was in good condition before the fall and had not been used a great amount.

It is concluded that this Friend failed due to torsional overload caused by a placement where the direction of loading in the fall was not along the axis of the device.

In view of the fact that we have seen this type of failure before it is recommended that a short article be prepared for Summit Magazine to point out that camming devices should be placed with care so that the force in a fall will be along the axis and any twisting of the device is likely to cause failure.
