BRITISH MOUNTAINEERING COUNCIL

TECHNICAL COMMITTEE MEMORANDUM TCM 10/03

Cracked Black Diamond Helmet

Incident ref: 02/10/F.KNO

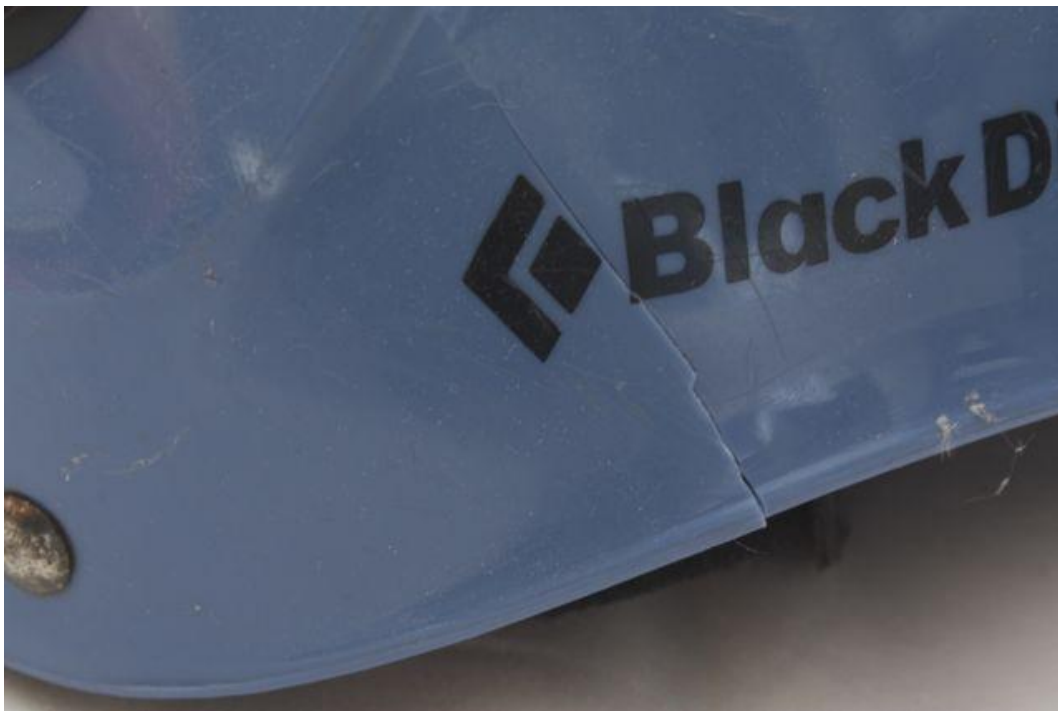
A crack approximately 50mm long is present in the rear rim of the helmet, just left of centre (Fig. 2).

Figure 2: Crack on rear rim

A load applied to both sides of the helmet would result in a bending force being exerted to the front and rear regions of the rim. It is possible that an excessive force in this region will have resulted in the crack forming at the rear.

The crack observed in this helmet is believed to have been caused when the helmet was excessively loaded in the lateral regions, causing a bending force at the front and rear rims and leading to cracking. The crack was initially observed when removing the helmet from a rucksack upon arriving at a climbing venue. Assuming the crack was not present if not observed when packing the bag, it is speculated that the damage occurred during transit. Packing a bag heavily, throwing a bag into a vehicle or sitting on a bag could all potentially cause the damage observed here. Black Diamond instructions for this helmet (www.blackdiamondequipment.com) instruct the user to maintain care when transporting the equipment.

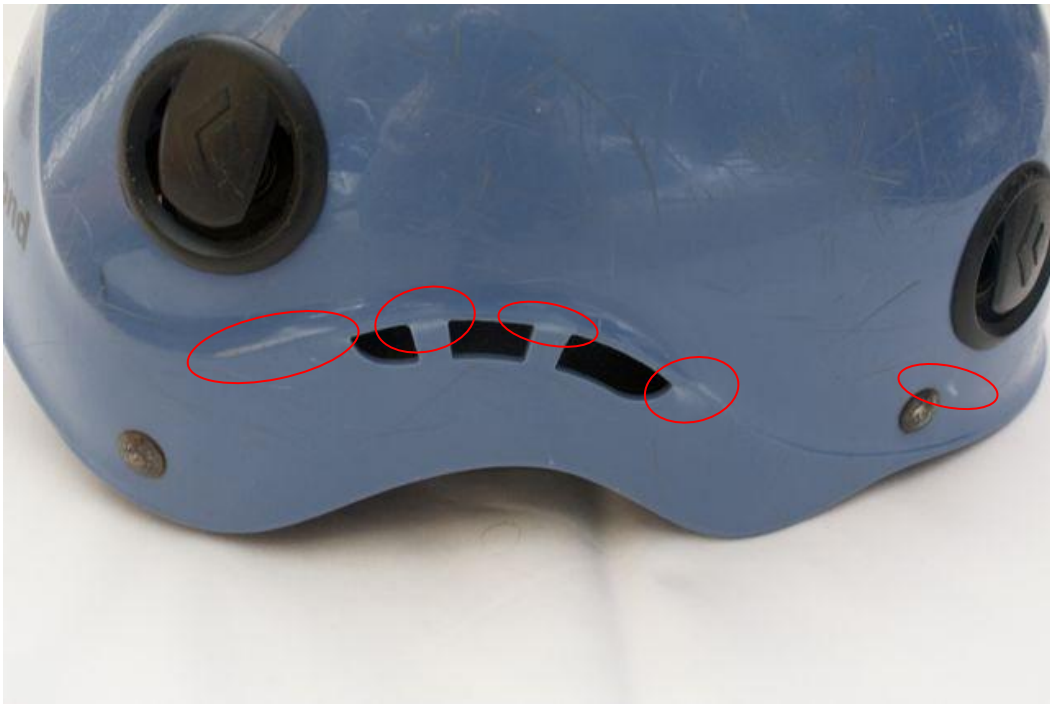
Further inspection of the helmet revealed a number of damaged areas on the lateral regions on the rim near the ventilation holes (Fig. 3 & 4). A number of white marks are visible at the top of each strut between the ventilation holes, and also adjacent to the anterior rivet on each side. These marks typically indicate that plastic deformation of the material has occurred in this region.

Figure 3: Helmet RHS with deformation marks circled

The helmet exhibited a large crack on the rear rim and plastic deformation marks on either side. Presence of these marks on both sides of the helmet suggests that some crushing force may have been applied simultaneously to the sides of the helmet.

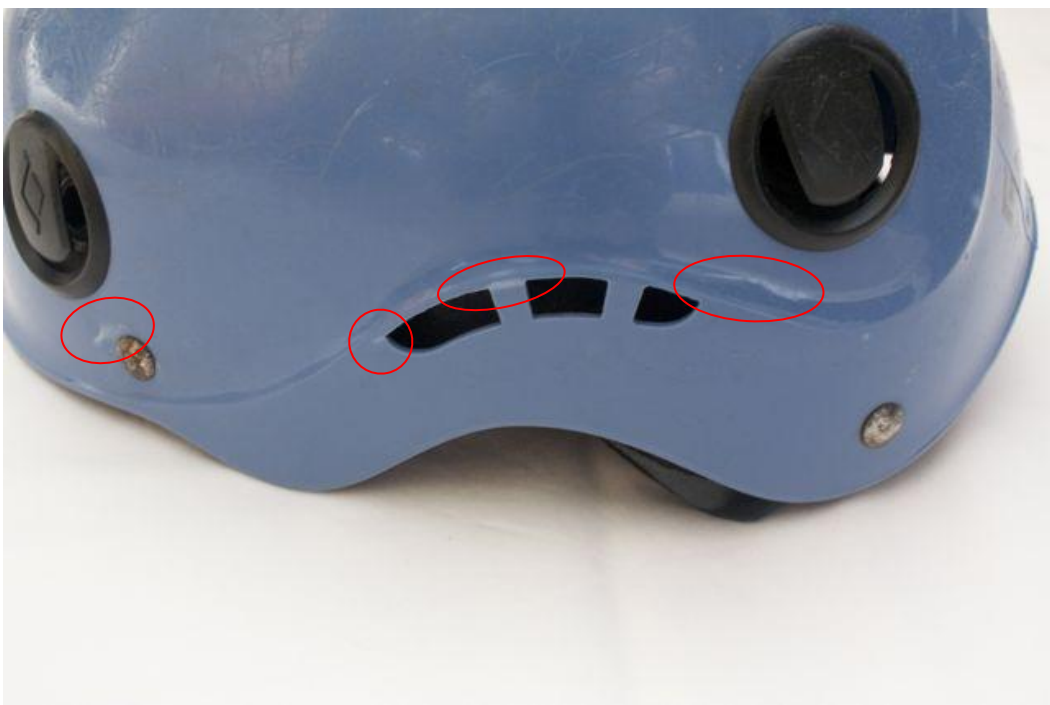
Figure 4: Helmet LHS with deformation marks circled

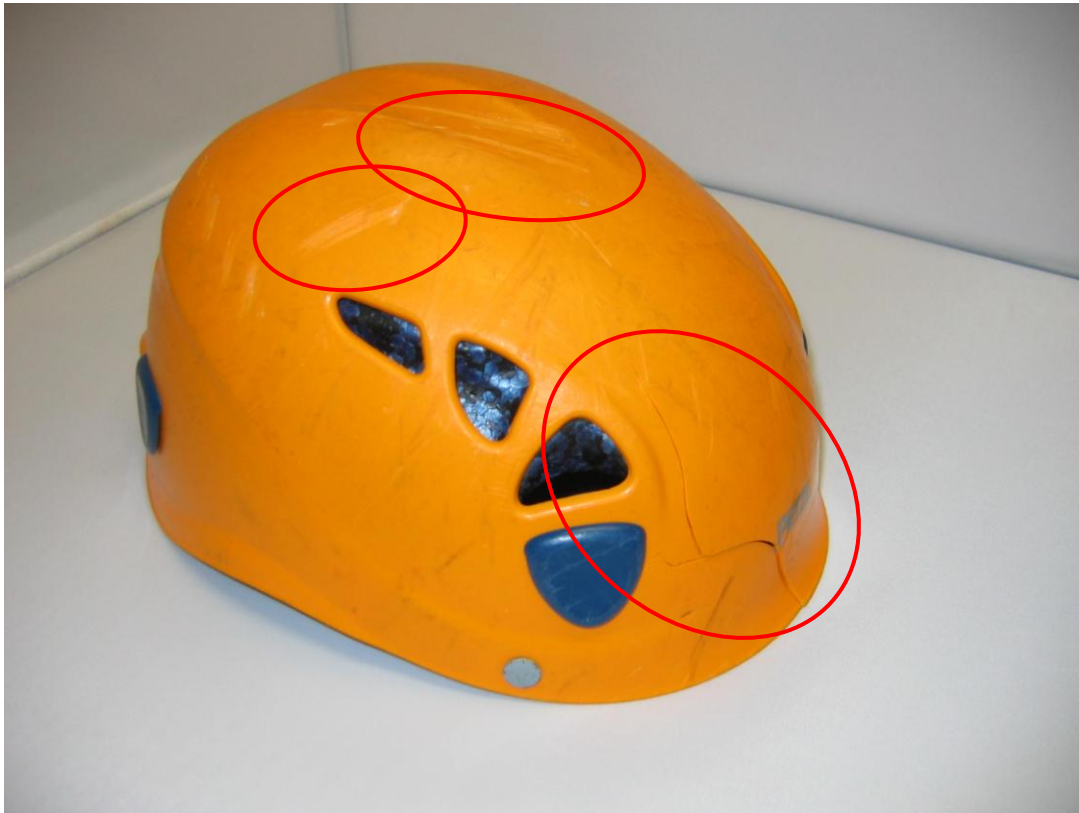
The damage on the Black Diamond helmet was compared with damage previously observed on another damaged helmet for verification purposes. The damage on this helmet of similar construction was known to be caused by a severe fall. As can be seen in Figure 5, the damage caused is a deep crack and abrasion marks (highlighted) which appears significantly different to the damage observed on the Black Diamond helmet. This suggests that it is unlikely that the damage to the Black Diamond helmet occurred due to a similar fall or impact.

Figure 5: Fall damaged helmet.
