BRITISH MOUNTAINEERING COUNCIL

TECHNICAL COMMITTEE MEMORANDUM TCM 02/06

Wild Counry Technical Friend with broken stem Incident ref: 02/05/L.WIL

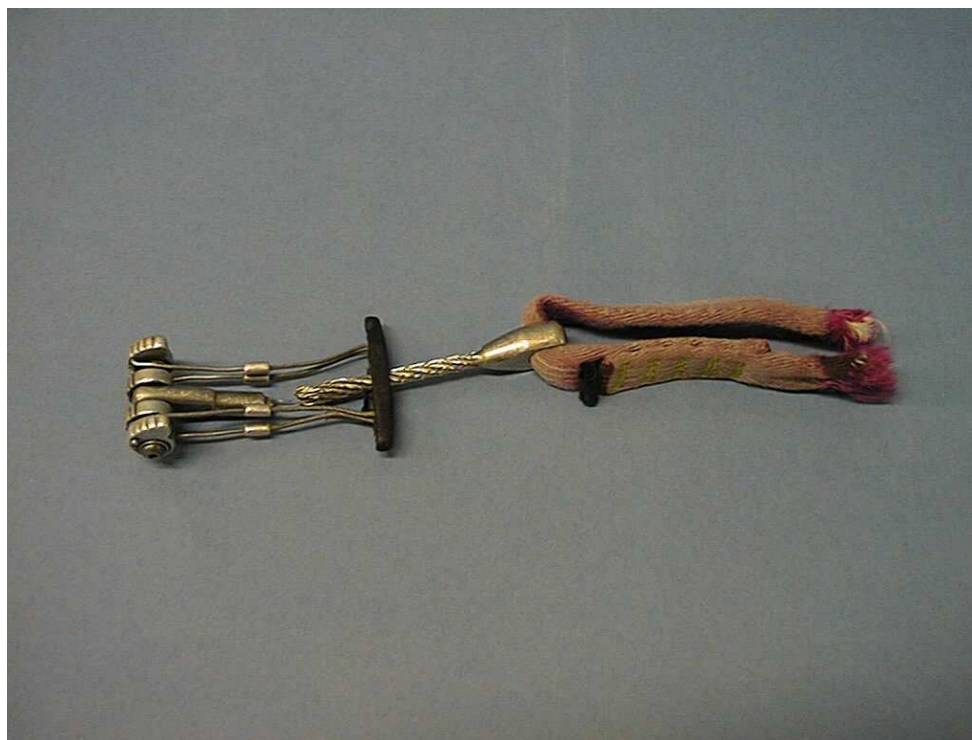
This flexible friend broke after repeated flexing of the stem.

Visual examination of the fracture surface revealed no sign of corrosion. The fracture occurred next to the soldered end of the stem.

It seems likely that the age of this device contributed largely to this failure. The friend was over 13 years old when it broke. Repeated bending of any metal can result in fracture, and it appears likely that for a considerable period prior to failure some of the wire strands were broken. The repeated flexing of the stem then resulted in fatigue failure of the stem. This is more likely to occur near one of the terminations of the wire as the radius of bending is reduced.

The instructions now given with friends state that the device should be discarded if there is any signs of broken wire strands. They also advise that the devices are checked every 3 months for any defects.

Climbers need to remember to check ALL their equipment on a regular basis, after all their life may depend on it. Climbers should also note that if they notice faults with any of their kit they should check it as soon as possible, not wait for it to break. Attention should be drawn to page 21 of the BMC Care and Maintenance booklet.
