# A&E

## LOOKING IN DEPTH AT ACCIDENTS, TO ASK THE CRUCIAL QUESTION: WHAT WENT WRONG?

After research on the web yielded no clues, Steve contacted the BMC Equipment Investigation Panel (EIP), and sent in the broken wire. The crux of the matter is why had a Walnut 0 (rated strength 2kN) failed due to overload of climber whose weight is just 0.74kN? What had gone wrong?

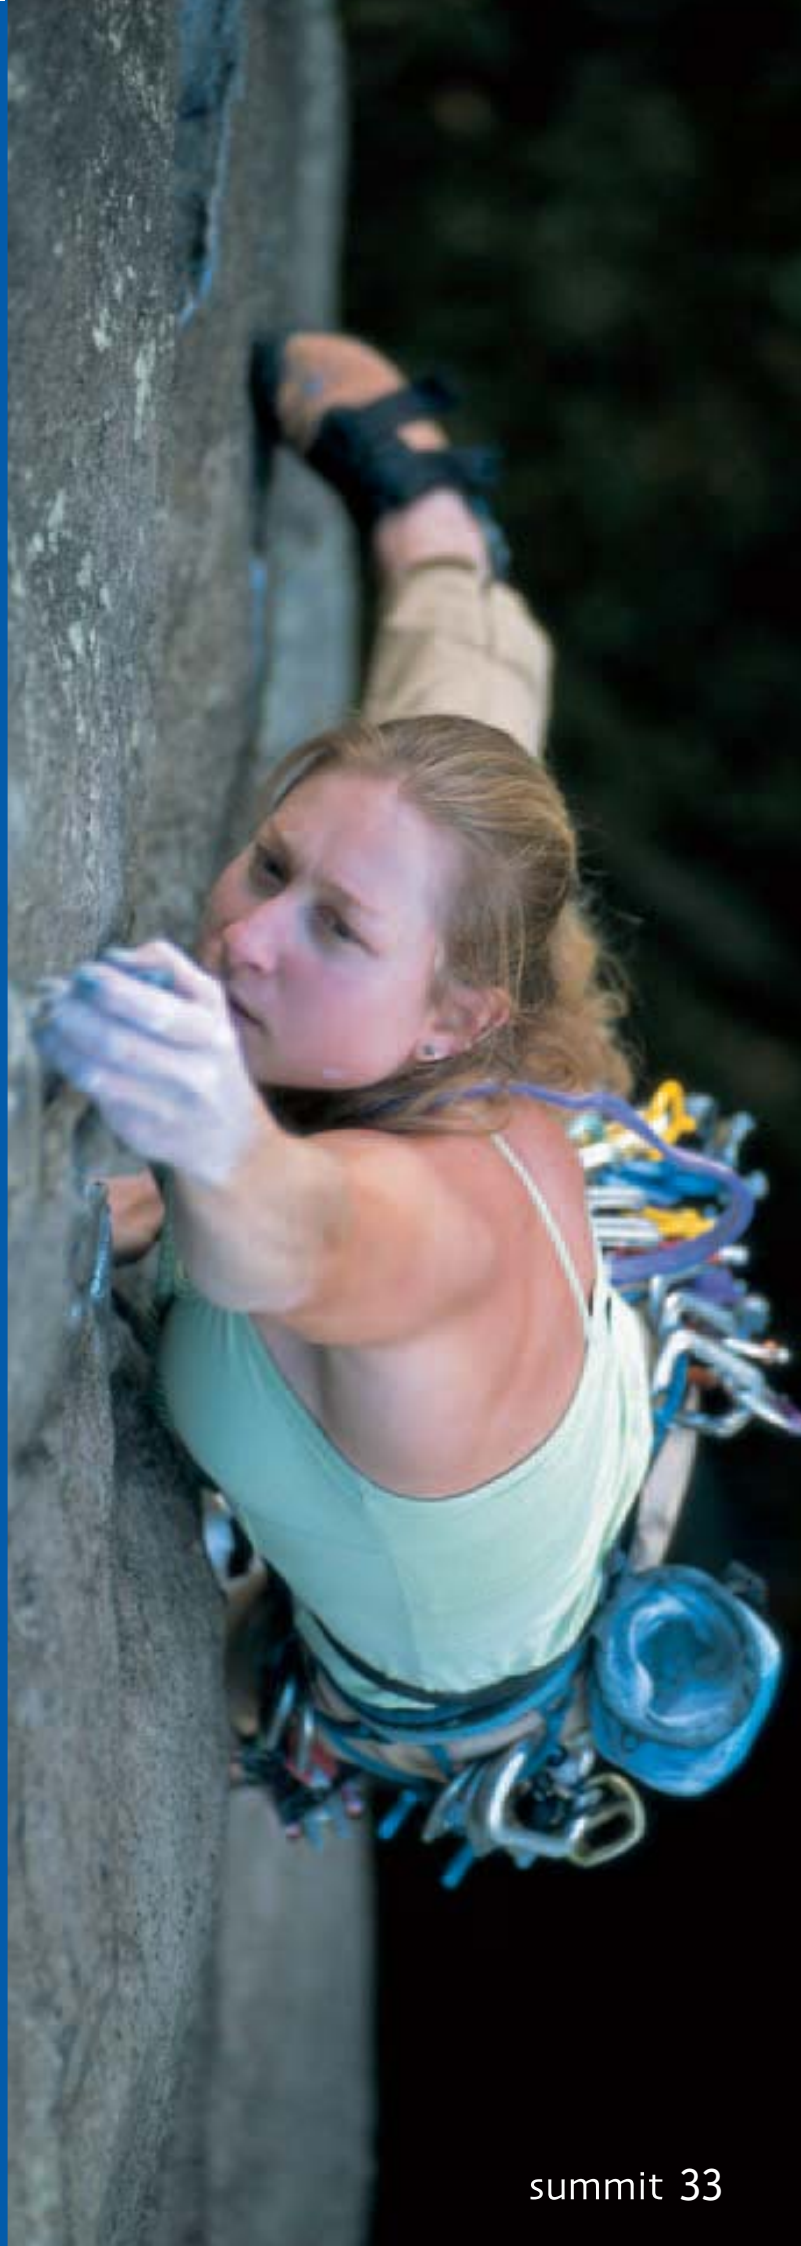
He started to pack his gear away, resigned to a long lay off, and found to his surprise that the size 0 Walnut had completely snapped, resulting in his ground fall. Steve explained, "this came as a total shock, I only weigh 75Kgs, I wouldn't have thought my weight would be sufficient to break the wire."

The broken wire was in very good condition, showing no other signs of maltreatment, and the breakage had occurred where you would expect, in the region of greatest stress-concentration. There were no indications of pre-existing defects, and microscopic examination showed nothing out of the ordinary. It was time to look at the details of the fall. Steve was only just above the top runner when he fell, so the number 4 ripping had very little effect on the fall dynamics. Essentially he fell from 2 – 3m above his real top runner, the Walnut 0. That meant a fall of 4 – 6m with approximately 8m of rope between him and his belayer, giving a fall-factor of 0.5 to 0.75. This is a significant fall-factor, and it's not surprising that a force of over 2kN would be generated on the runner. In fact in tests carried out by the BMC Technical Committee, it was found that in typical fall situations it was not difficult to generate forces between 6kN and 7kN on runners.

So, if the nut had taken the force of the fall, and the belayer had made a determined effort to hold the rope, the force on the nut would have been between 6 and 7kN. Even using a thin rope and slick belay device it would still have been 4kN. Given that the rated strength of the Walnut 0 is 2kN, failure was inevitable. Of course, the actual strength of protection will be higher than the value stated by the manufacturer. The UIAA and EN standards both require the manufacturer to state a strength below that which they can ensure. Hence DMM ensure that all Walnut 0 nuts will fail at a load greater than 2kN, and their average failure strength is actually about 3.4kN.

All this shows that in a significant fall (fall-factor 0.5 or above), where the belayer is making a serious effort to hold the fall, the force on the top runner is likely to be between 6 and 7kN. For a climber to feel confident that their runners will hold without breaking, they should have a minimum strength of 7kN. And even this does not guarantee security, since higher forces can be generated in some high friction situations. Remember that a Walnut 0 and all other micro protection (including nuts and some of the latest micro cams) with a similar strength rating are only intended to be used where the nature of the rock prevents the use of bigger, stronger protection. In some situations it may be possible to share the load across several micro-nuts, but if this is not possible, you should take a moment to appreciate the limited security provided, and act accordingly... II
