BRITISH MOUNTAINEERING COUNCIL

TECHNICAL COMMITTEE MEMORANDUM TCM 07/03

ROCK EMPIRE CAM, SNAPPED WIRE CABLE

Incident ref: 07/10/I.SAR

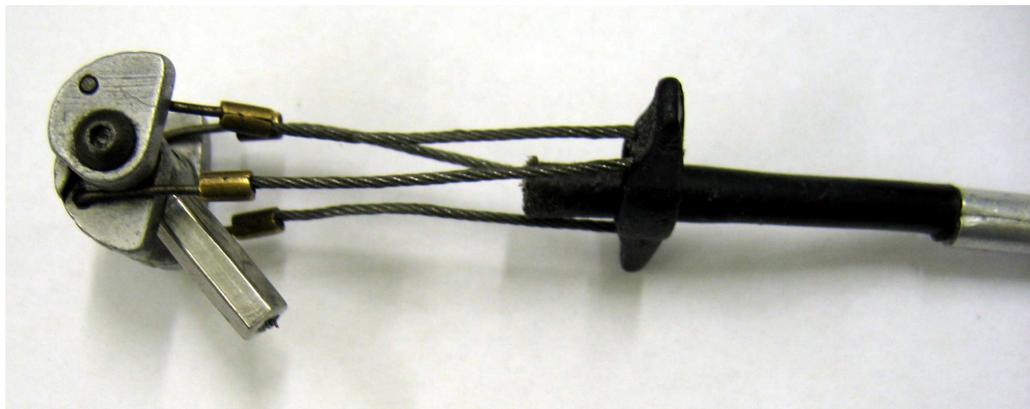
The wire cable snapped during a fall, fortunately not leading to any serious injuries. Fatigue failure of the cable caused by repeated bending was found to be the likely cause. The design of the sleeve and the specification of cable were felt to be contributory factors. The difficulty of detecting broken wires in the cable was felt to be a flaw in the design, given that in all other respects the unit appeared to be in good condition, albeit well used.

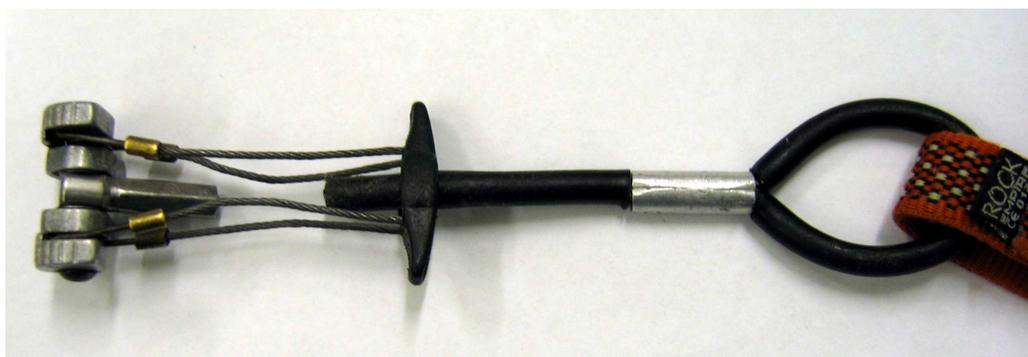
The wire cable was broken fairly cleanly at the junction between the cable and the solid stem. The wire cable shows no evidence of corrosion or damage other than at the break. Viewed end on, the remaining wire is located centrally and evenly inside the stem. No wire strands appear to have come free from the swaged socket.

The black plastic sleeve covering the wire stem was indented and scuffed. The orange sewn-in sling was in a good condition.

The nature of the break strongly suggests that the wire cable has failed as a result of bending fatigue, caused by repeated flexing of the cable.

The method of construction results in bending forces being concentrated at a single point; the plastic stiffening sleeve prevents the wire from bending too much when, for example, the trigger is activated, but concentrates any bending at the junction between the sleeve and the solid stem.

The design of the stem concentrates bending stresses at the eventual point of failure of the wire. Using a thicker and stiffer cable would give improved fatigue resistance. In addition, the bending stresses could be more evenly distributed if the plastic stiffening sleeve did not butt up against the stem/cable junction, but overlapped the junction area.

Using a clear plastic sleeve would greatly assist the user in being able to detect damage to the cable before final failure could occur, with the design found here this is almost impossible.
