TECHNICAL COMMITTEE MEMORANDUM TCM 05/08

Broken Salewa Karabiner

Incident ref: 05/11/C.KOC

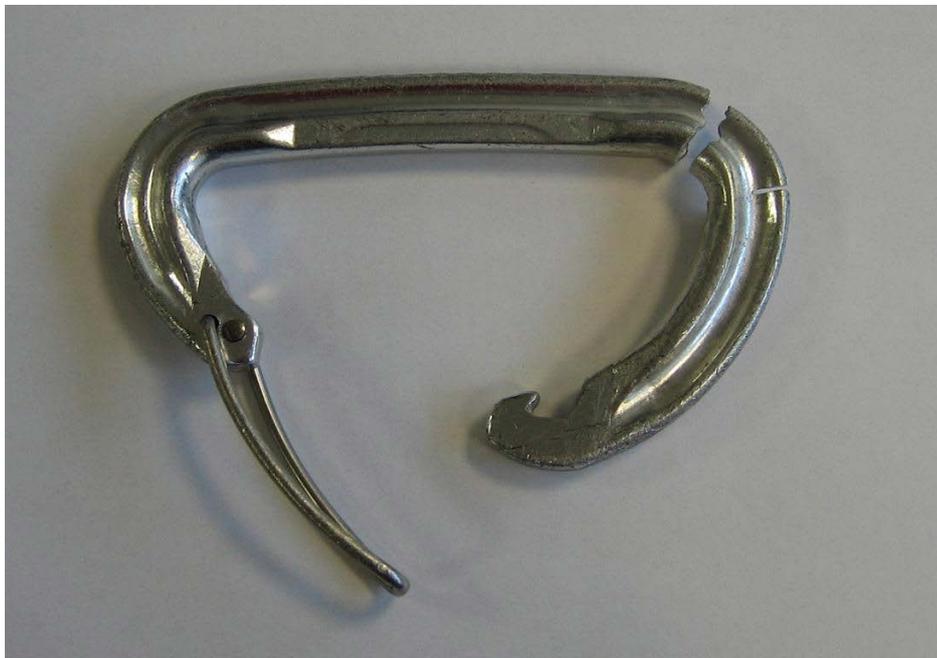
The failure mode of the karabiner is consistent with the sling attached to the protection being hooked in the nose of the karabiner holding the gate open and loading it inappropriately.

The broken karabiner has broken near to the top of the spine of the karabiner. The karabiner is of the wire gate type. The spine shows it to have a major axis strength of 24 kN, a minor axis strength of 7 kN and a gate open strength of 9 kN. It also has UIAA and CE marks on it.

The fracture surface of the broken karabiner shows no apparent defects and is consistent with ductile failure due to being overloaded.

The karabiner failed due to being loaded close to its nose with the gate being held open. This was most likely caused by the sling of the protection cam being caught in the nose of the karabiner holding the gate open and loading the nose when the climber fell.

There have been several reported failures of karabiners by this mechanism. Climbers are reminded to ensure that equipment is correctly clipped with the gate of the karabiner closed and in an attitude where it is unlikely to be opened accidentally.
