BRITISH MOUNTAINEERING COUNCIL

TECHNICAL COMMITTEE MEMORANDUM TCM 07/02

HB Screwgate Karabiners, worn Incident Ref. 07/02/C.WIL

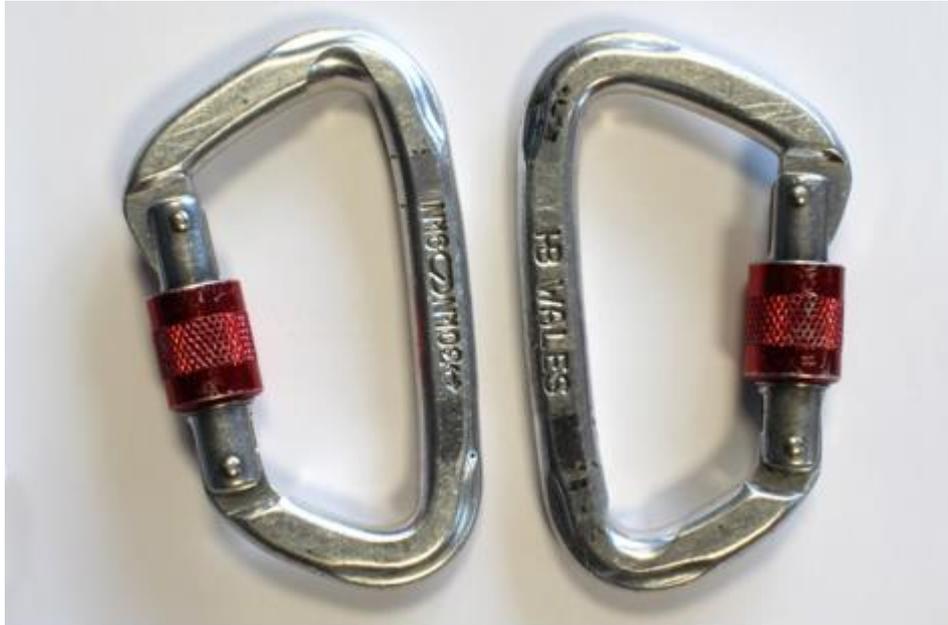
Figure 1. The Worn HB Screwgate Karabiners

Karabiner No.1 is on the left and Karabiner No.2 is on the right

Initial inspection does indicate severe wear in both the karabiners on an internal radius close to the back of the krab. Other than this wear these karabiners look comparatively unworn. The gate and the screw mechanisms on both connectors operate smoothly as would be expected from light use. The spring mechanism on both of these karabiners is intact and undamaged. There are no excessive surface defects or imperfections on the karabiners. The images in Figure 2 and Figure 3 show this wear in greater detail

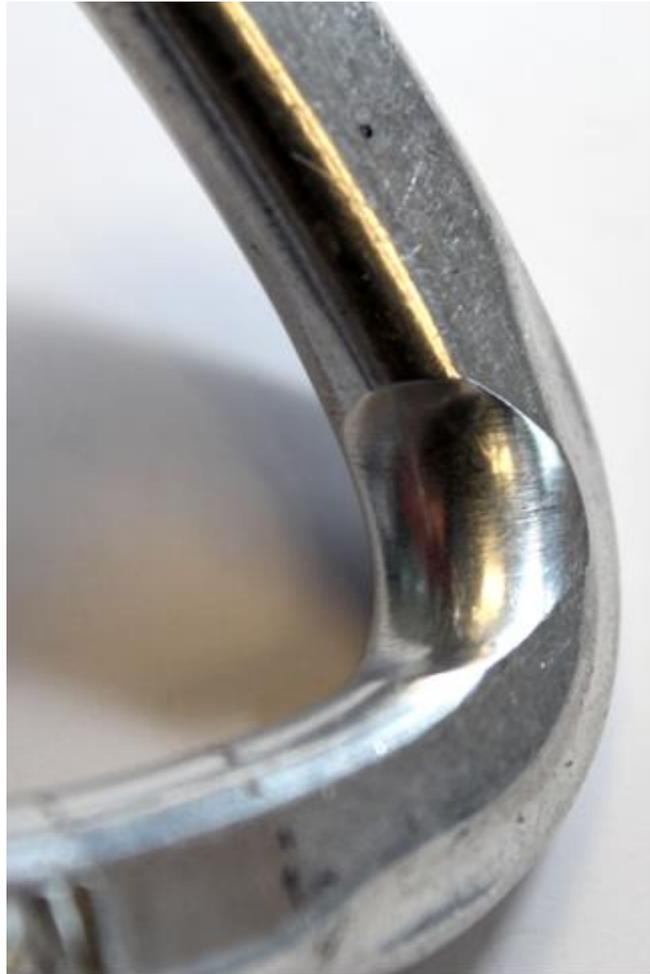
Figure 2. Detail of the Wear on Karabiner No.1

On the worn surfaces clear striations can be seen. The transverse direction of these striations confirms that the reported wear was produced by something (the rope) running over these radii. The wear seen on these karabiners is such that at its periphery it has produced sharp edges.

These karabiners were sent to the BMC because of concerns over the unusually high degree of wear exhibited. The images (Figure 2 and Figure 3) show that these karabiners have been subjected to a high degree of wear for reportedly only being used twice.

However, the report included with the form states that these karabiners were used to increase the friction in a lower off situation. Using a karabiner in this manner does subject the karabiner to a high friction loading. The situation described, that these karabiners were subjected to, has the additional factors of wet ropes, due to the climbing on ice and, probably, grit picked up from the rock sections of the particular climb. These factors are likely to have exacerbated the wear by providing an abrasive (the grit) and a cutting fluid (the water) to increase the rate of wear.

There are many ways to try and avoid such high wear on climbing equipment such as this. The most important point to emphasise is, like was done, is to check the equipment regularly and retire any suspect equipment. Another thing that could be done would be to use steel karabiners rather than aluminium ones in this scenario where there is likely to be a high degree of rubbing and a chance of abrasion. The improvement in hardness of the steel karabiners over that of aluminium ones will reduce the degree of wear and so increase the life.

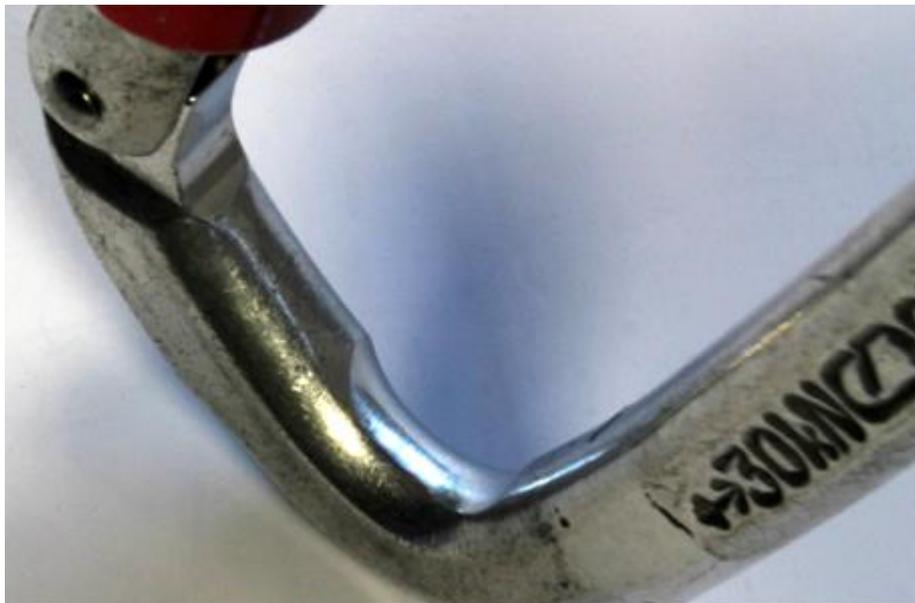
Figure 3. Detail of the Wear on Karabiner No.2

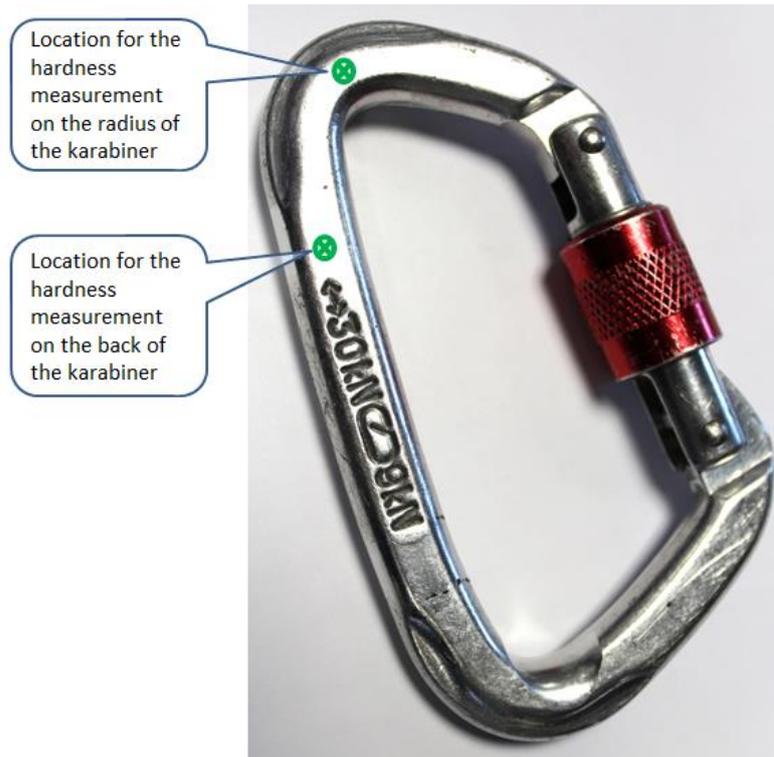
Figure 1. Locations where Hardness Testing was done

To get an estimate of the material strength of these karabiners, hardness testing was done on both karabiners. The hardness of each karabiner was measured in two places using the Brinell method. All measurements were taken on the flat sides of the karabiners. One hardness measurement was taken at a location near the “Radius” at the back of the karabiner. This was done on the radius opposite the worn radius because a flat surface was needed to do the measurement (Figure 4). The other hardness measurement was taken along the “Back” of the karabiner. Table 1 details the results of these hardness measurements.

Aluminium karabiners are usually made from 7075 T6 aluminium alloy, which normally has a hardness of 174 Brinell (88 RB) and the material is likely to be slightly work hardened during the manufacturing process. The hardness values recorded in Table 1 do not seem unreasonable and indicate that the material used to make these karabiners is not unduly soft/weak.
