### TECHNICAL COMMITTEE MEMORANDUM TCM 11/01

## Low-stretch rope, Snapped rigging rope for Tyrolean Incident Ref. 01/11/B.KIN

### SUMMARY

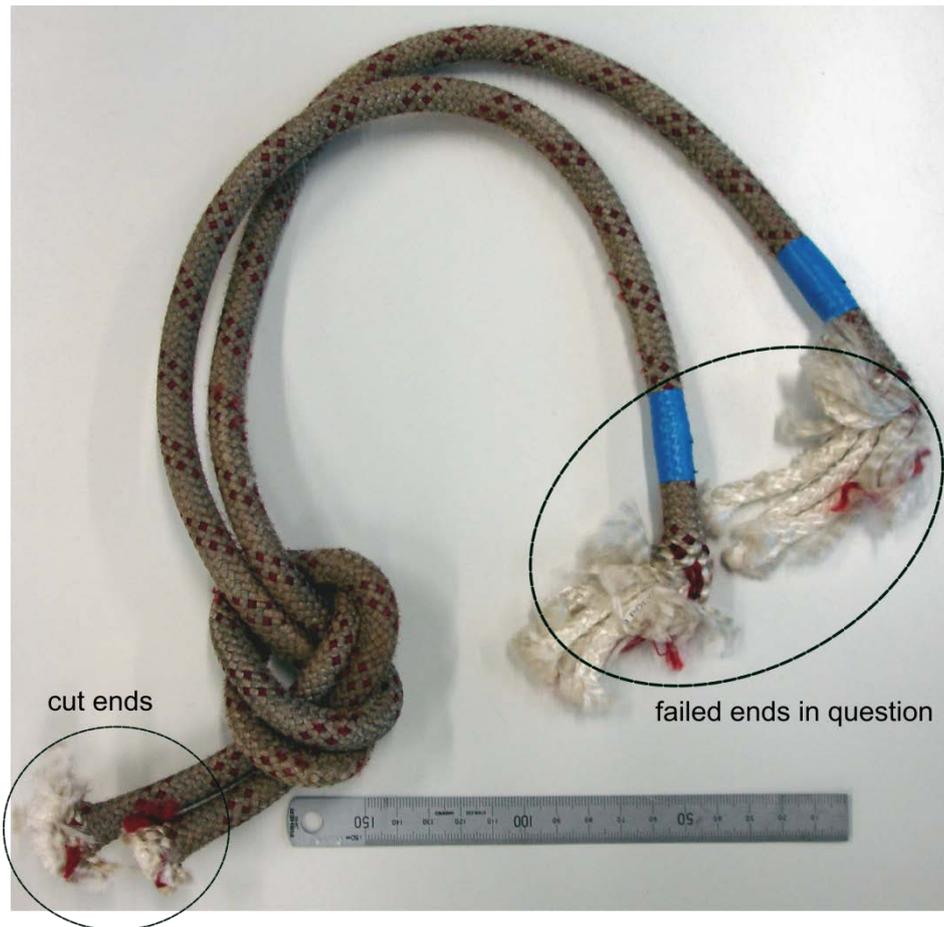
Figure 1. Image of the received section of rope.

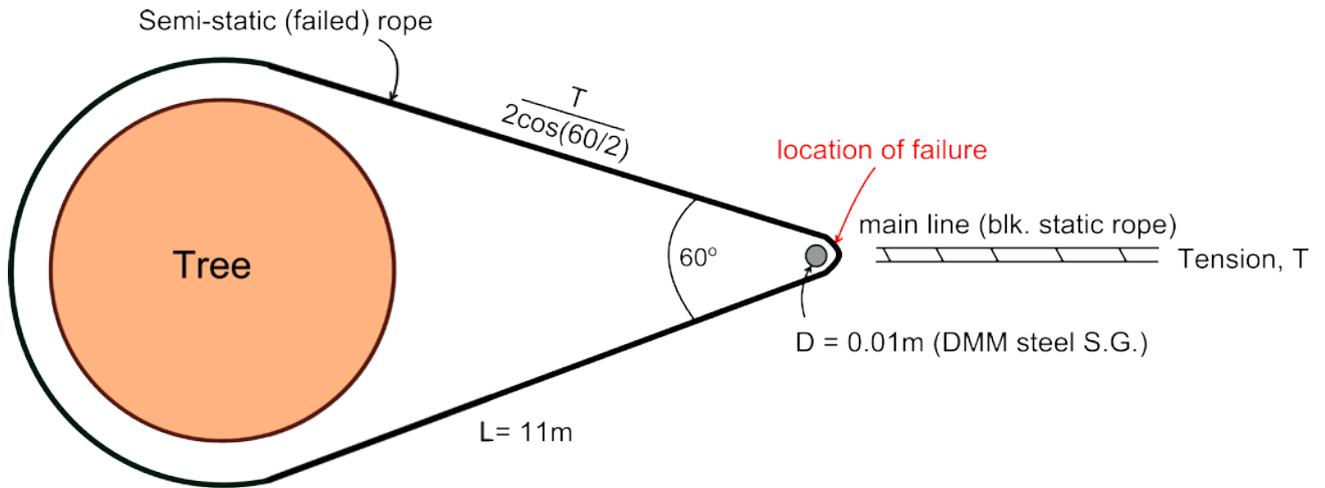
This 11m section was slung around a tree with a single loop, see Figure 2. The broken region was in contact with a Ø10mm DMM carabiner at a 50/60° angle to the tree. Hence the tension in the tree anchor rope is about 0.58\* (tension, T, in main line).

Figure 3. Schematic of the set up that was described.

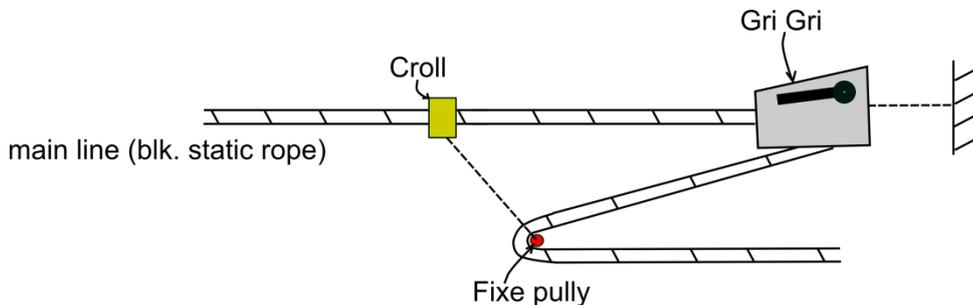
A 3:1 pulley system was created using a Croll and Fixe pulley attached to a Gri Gri, see Figure 3. All participants pulled on the rope to pre-tension the system before and after each Postman's walk. Hence loading could be assumed to be around 7.5 kN\* in the system, before the climber crossed the rope.

Figure 4. Three to one pulley system that was described.

The figure of eight-on-a-bight on the fixed end was so tight, that they were left on the rope and **could not be opened** between times of rigging of the traverse use – verifying that the pretension in the system was likely to be very high.

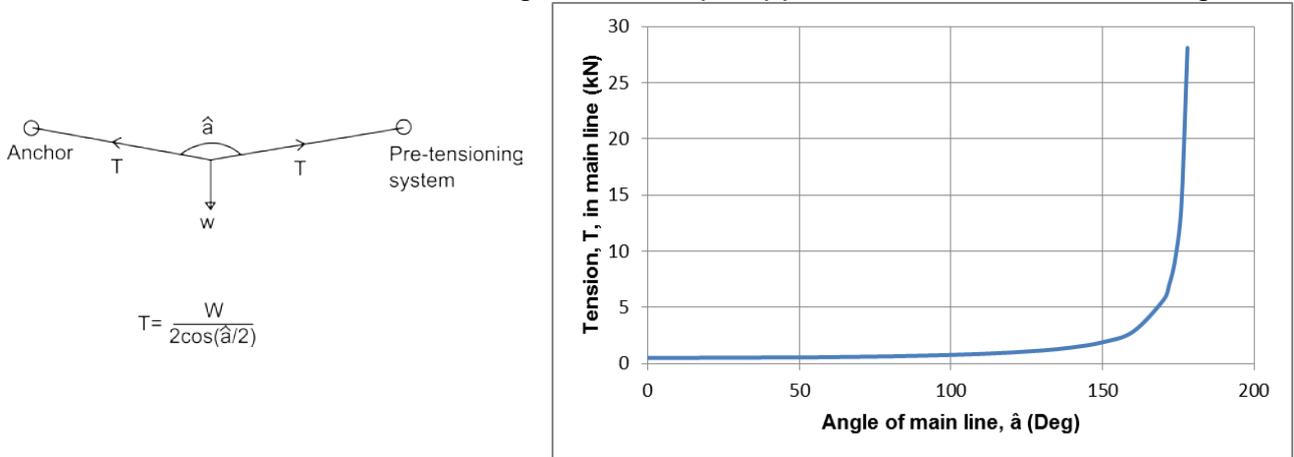
It is entirely possible that the ropes dynamic safety limit was exceeded. The specification data states that the rope is capable of 15 falls exceeding 100kg (1 kN of force, see Appendix II). With a highly tensioned rope, it is possible to produce very high tensions in the main line as the angle of the rope approaches 180°, shown in Figure 5.

Figure 5. Tension in rope as a function of the angle – for a force of 981 N (100kg mass).

Given the information that was received, unfortunately, it is not possible to conduct an accurate stress analysis. However, it can be shown that with this set up, and the basic assumptions that were outlined, that the climber could easily apply a load in excess of 10 kN on to the system, and thus contribute to the failure of this set up [4].

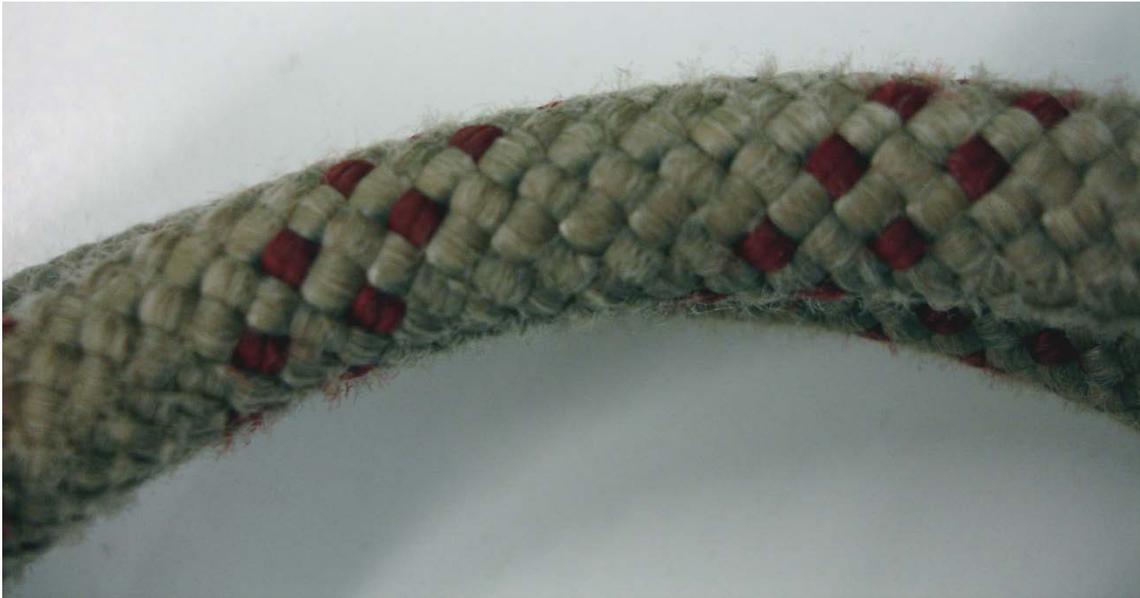
This repeated fatigue loading at the pursuits centre, combined with environmental fatigue (the rope appears to be very dirty and old, see Figure 4 and [2].), and the stress concentration of the small radius of the screw gate all contributed to the failure of the rope. Given that the rope failed at the stress concentration caused by the screw gate, rather than the knot, one could postulate that the rope will have failed at somewhere between 30-70% of the maximum strength of the rope [3]. It is interesting to note that the tree anchor rope failed rather than the black main line despite the rope diameters being similar (10.5 mm versus 11 mm). The tension in the tree anchor rope being estimated as 0.58 times the main line tension. It is possible that this was due to the tree anchor rope being left outside between seasons, whilst the black main line was packed away during the winter.

Figure 6. Image showing signs of environmental damage and dirt on the sample rope.

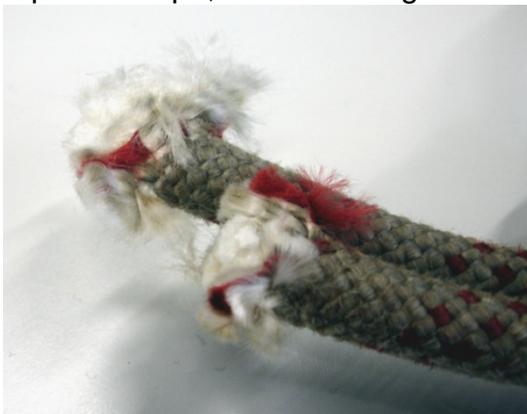
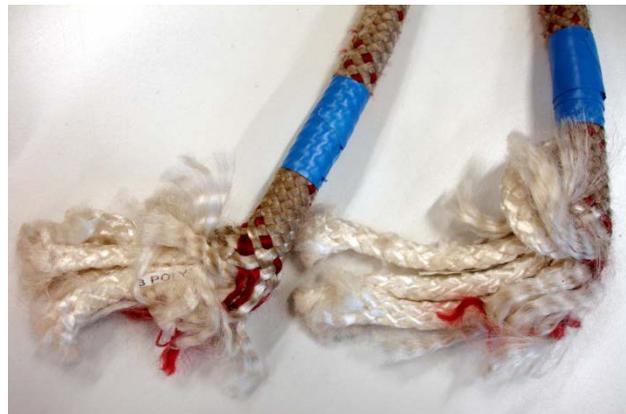
The rope in question is a Beal 10.5mm Spelenium semi static (see Appendix II for rope specifications). Optical microscopy was conducted on the cut end of the rope, and a sample from the failed end of the rope. There are obvious differences between the two samples of rope, shown in Figure 5.

Figure 7. Images of (a) a cut end and (b) the failed end of the semi static rope.

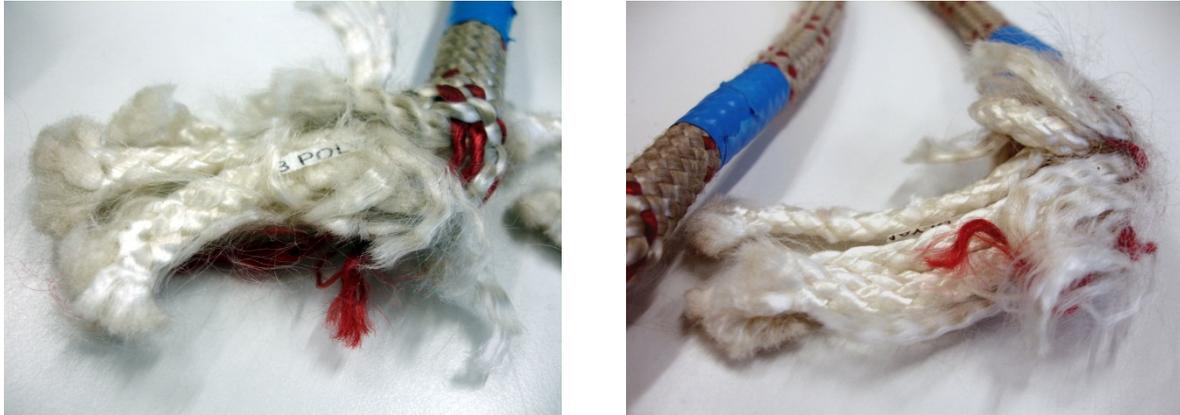
The failed end of the rope shows that the core is exposed a reasonable length down the rope, about 40 mm at each end, shown in Figure 6. It is clear from the image that the cores are kinked to the left (in the images), hence indicating plastic deformation having occurred in the polyamide (PA) core of the rope. When the rope was examined, no evidence of failure due to cutting or abrasion could be identified.

Figure 8. Close up images of the failed end of the rope.

There was significant evidence of necking of the fibre ends close to the failed region. This is indicative of a quasi-static or fatigue type loading from the applied tensile load. Final failure obviously occurred via a dynamic load applied to the system; however, it seems that damage had already occurred to the rope from the rigging.

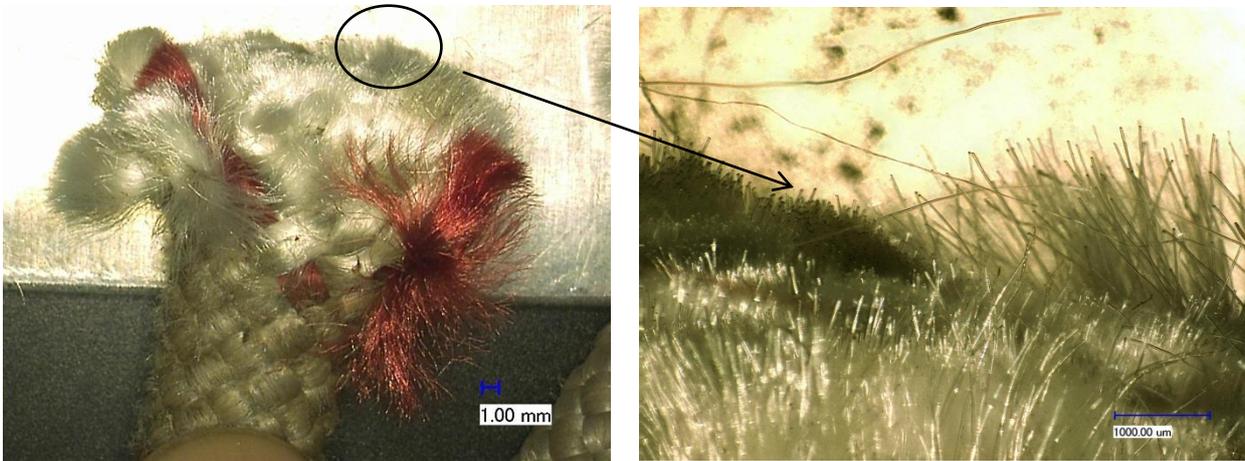
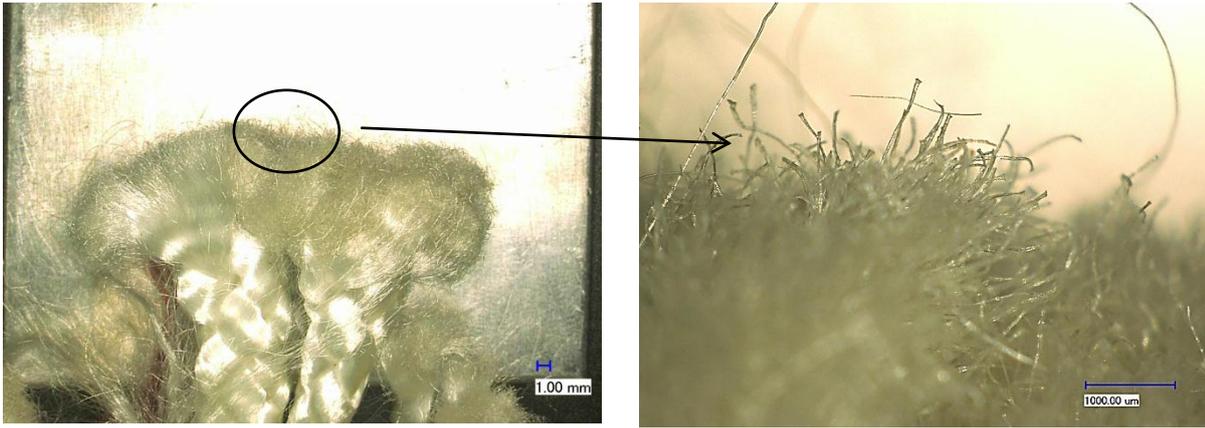
Figure 9. Microscopy images of (a) a cut end and (b) the failed end of the semi static rope.

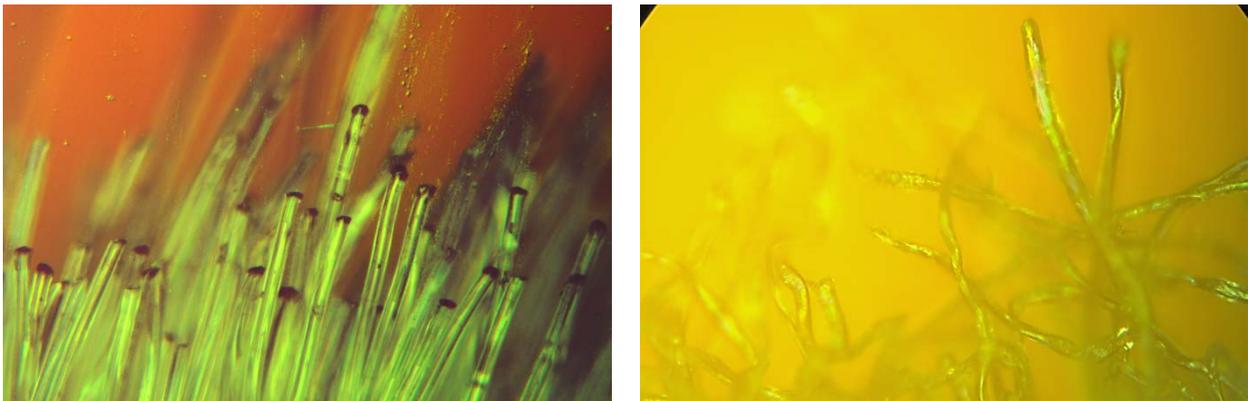
If one compares the failed fibres and cut fibres at high magnification (Figure 6), distinct differences can be seen. The cut fibres are straight, aligned, and have clean ends at the point of cut. The failed fibres show evidence of fibrillation and tensile drawing, indicative of a tensile loading failure. It is most likely that this initiated at the core, on the outside of the rope (side not in contact with the carabineer), and progressing through cross section of the rope.

Figure 10. High magnification microscopy of the rope, showing (a) a cut end and (b) the failed end of the semi static rope.
