**TECHNICAL COMMITTEE
MEMORANDUM TCM 11/02**

**Petzl Meteor III Helmet Headband Clip Failure
Incident Ref. 09/11F.HUY**

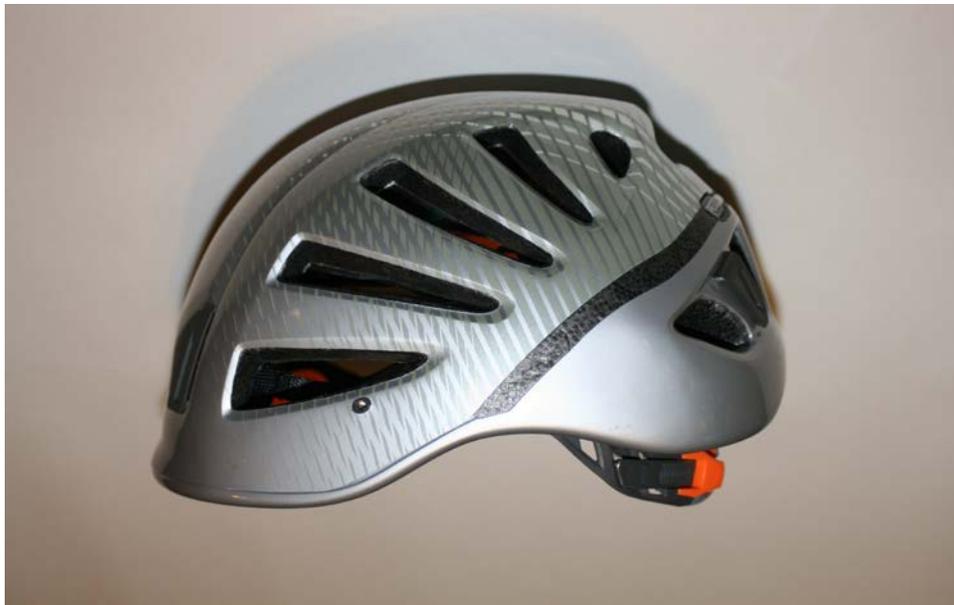
Figure 1. The Reported Petzl Meteor III Helmet

This Petzl Meteor III has a faulty adjustment clip on the lefthand side of the headband. The helmet is just over a year old and it shows no signs of damage or wear other than the above reported fault.

Other than the cracked adjustment clip, the helmet shows no signs of excessive wear (Figure 1). The helmet is in fact in a very good condition reinforcing the reporters comments that it was only worn four times.

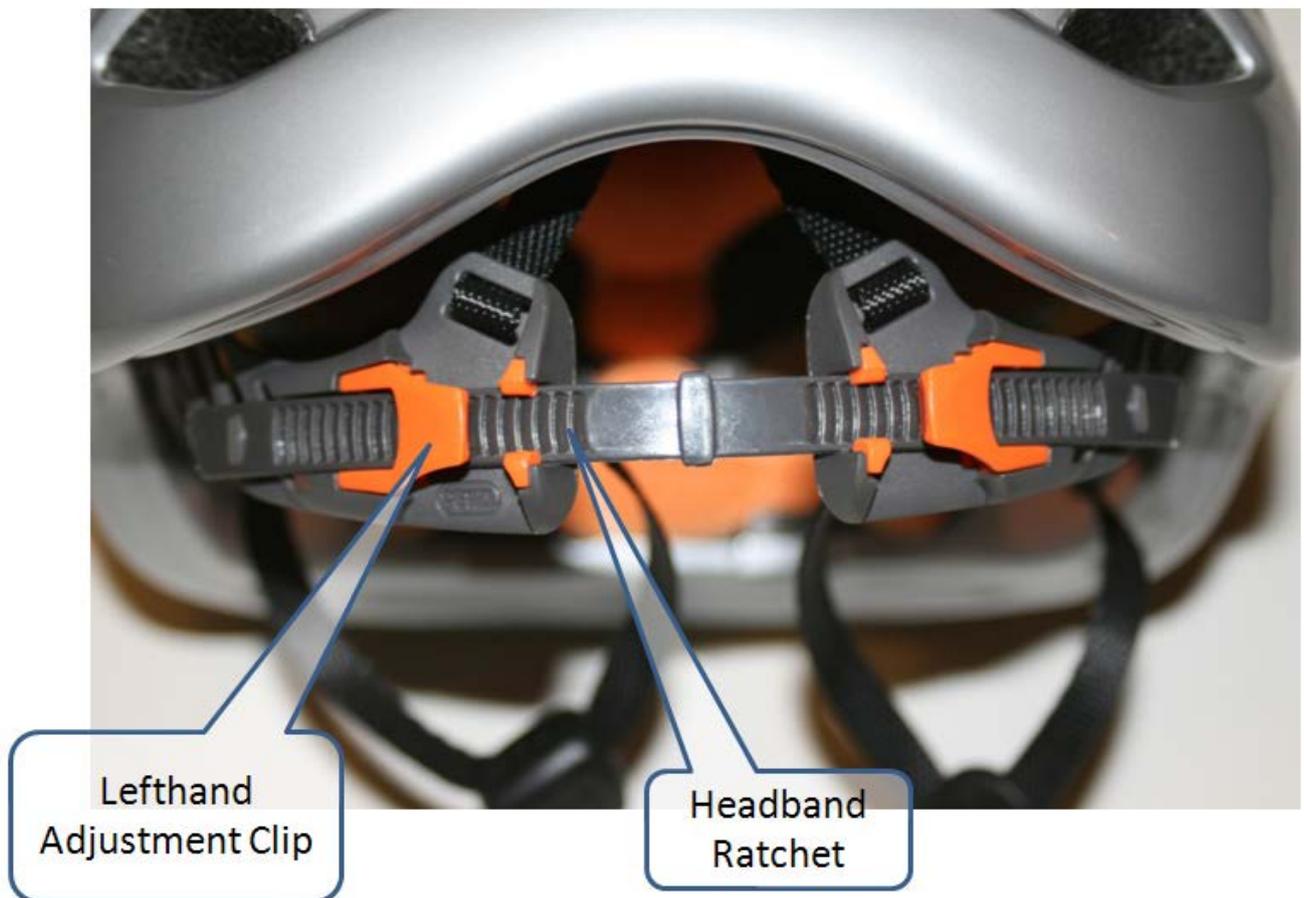
Figure 2. Picture Showing the Lefthand Adjustment Clip

On initial examination of the helmet, it was obvious that the lefthand adjustment clip (Figure 2) was not gripping the ratchet. The righthand adjustment clip grips the headband ratchet as would be expected even when a reasonable degree of force is applied to it.

Initially it is not immediately obvious whether this lack of grip is due to the clip losing its pre-load or due to the tooth face being damaged.

Removing both of the adjustment clips from the headband enabled a more detailed comparison on the tooth (gripping) faces. The comparison shows very little difference in the gripping surfaces of the adjustment clips. This confirms that the lack of grip is due to a problem with pre-load on the ratchet surface.

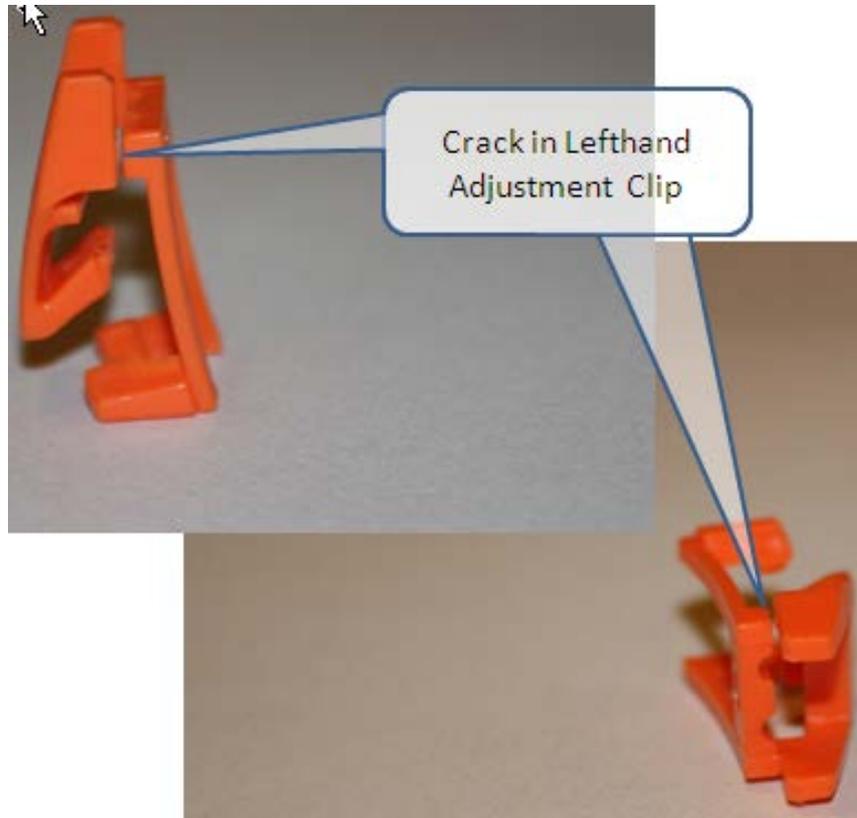
Figure 3. Details of the Crack in the Lefthand Adjustment Clip

Once removed, it was obvious that the lefthand adjustment clip has a through thickness failure of the upper leg (Figure 3) which is increasing the flexibility of the clip and reducing the pre-load that the clip exerts on the ratchet.

The crack in the upper leg of the lefthand adjustment clip is reducing the sprung pre-load that the clip can exert on the ratchet. This is obviously the reason for the clip slipping on the headband ratchet.

The lefthand headband adjustment clip no longer grips on the headband ratchet. This lack of grip on the ratchet is due to a crack all the way through the upper leg (Figure 3). It is unlikely given the short life of the helmet that this crack is due to excessive use or abuse. These facts indicate that the cause of the crack to be in some way due to manufacturing issues.

Without detailed knowledge of the manufacturing process it is hard to determine whether the crack in the headband adjustment clip was caused by poor design, poor material, a poor manufacturing process or a mix of all of these. However, a change in the design to reinforce this section of the adjustment clip could help to reduce the likelihood of cracking at this location.

Taking into account these facts I recommend the manufacturer, Petzl, review the design of this headband adjustment clip part of the Meteor III helmet to improve its durability.
