### TECHNICAL COMMITTEE MEMORANDUM TCM 13/01

## Broken rope: University of Leicester Mountaineering Club Incident Ref. 01/13/B.HUL

### SUMMARY

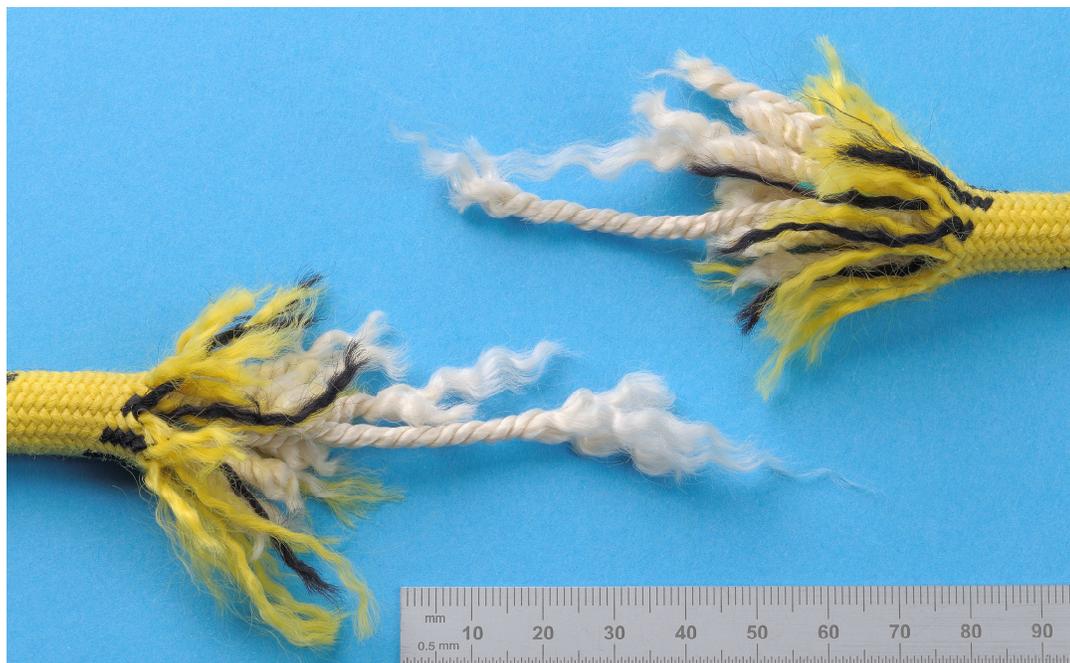
The broken rope pictured below, has been examined by TWI Ltd, acting in a *pro bono* capacity on behalf of the BMC. The damage is consistent with contamination of the rope by acid, specifically sulphuric acid.

The broken rope arrived at TWI on or shortly before 7 March 2013. The shorter length of rope (3-4m long) was labelled 'rope attached to climber', whilst the longer portion was labelled 'rope attached to belayer'. There were no obvious signs of wear to the outer sheath, or damage other than the complete failure shown in the photo. A turquoise thread, assumed to be a certification tracer, can just be seen on the right-hand side.

The tests carried out so far show that the broken area of the rope had been contaminated by sulphuric acid, and that the area remote from the break was not contaminated by that acid. It is not clear when and how the contamination occurred, and of course the tests carried out to date do not directly link the failure to the presence of the acid. The issue of whether the weight of the climber could have caused failure (given contamination by acid) could be addressed by mechanical testing, for example tensile testing to failure of both clean and contaminated rope, and a comparison of failure loads. TWI Ltd does not have the specialist rope-testing grips that would be required for such an exercise, but it is assumed that a rope manufacturer would.

To date, the manufacturer of the casualty rope has not been identified. The findings of this report should be widely publicised to increase user awareness of the importance of the care and storage of ropes, and in particular their protection from acids.
