TECHNICAL COMMITTEE MEMORANDUM TCM 14/02

Wild Country Nitro Snap Gate Failure

Incident Ref. 05/14/C.SCH

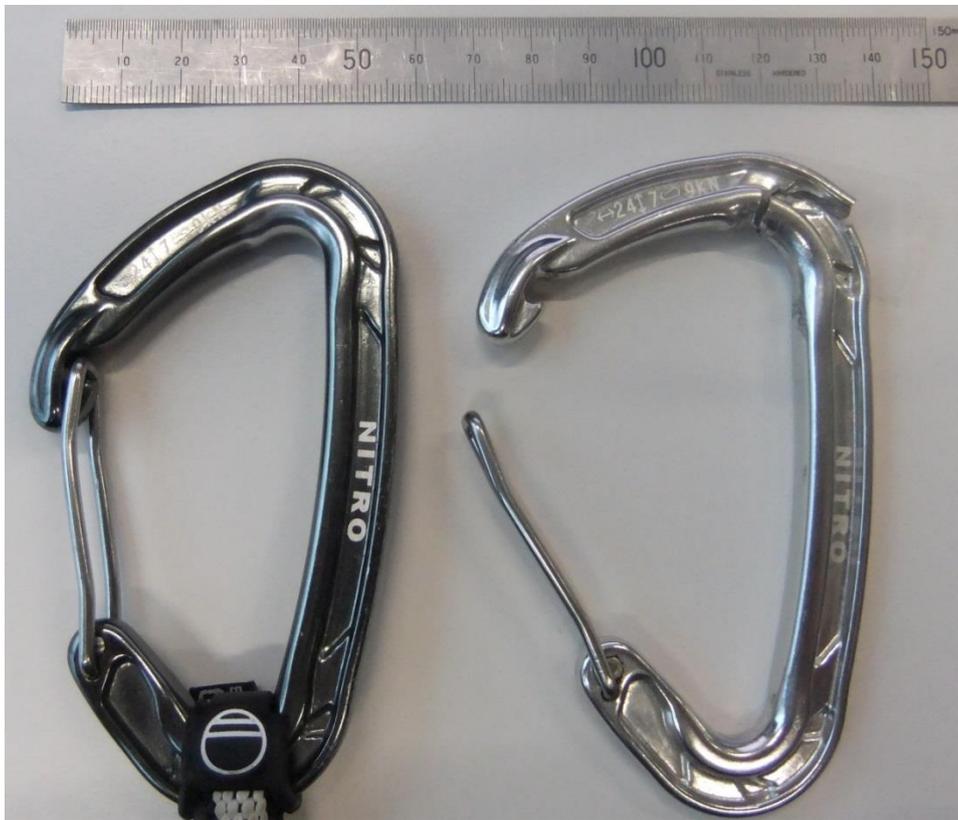
By comparing the rope side (1 Left) and gear side (1 Right) of the quickdraw, one may note plastic deformation and crack failure in the shoulder of the karabiner. The component otherwise appears as new, with no evidence of environmental degradation.

Figure 1. Shows (Left) rope side of the quick draw and (Right) the gear side that has failed at the radius where the rope runs.

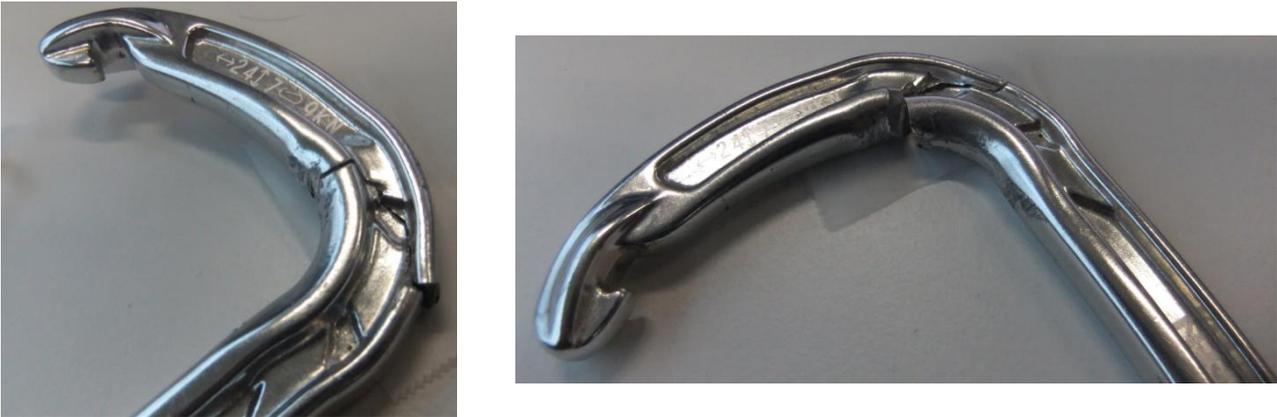
Plastic deformation was found to be present, by the observation that the karabiner fits together either on the front side (2 Left) or the back side (2 Right), but not both. The nature of plastic deformation also indicates that failure has occurred via bending failure and crack propagation from the inside of the karabiner, outwards.

Figure 2. Closer examination of the karabiner shows that plastic deformation is apparent.

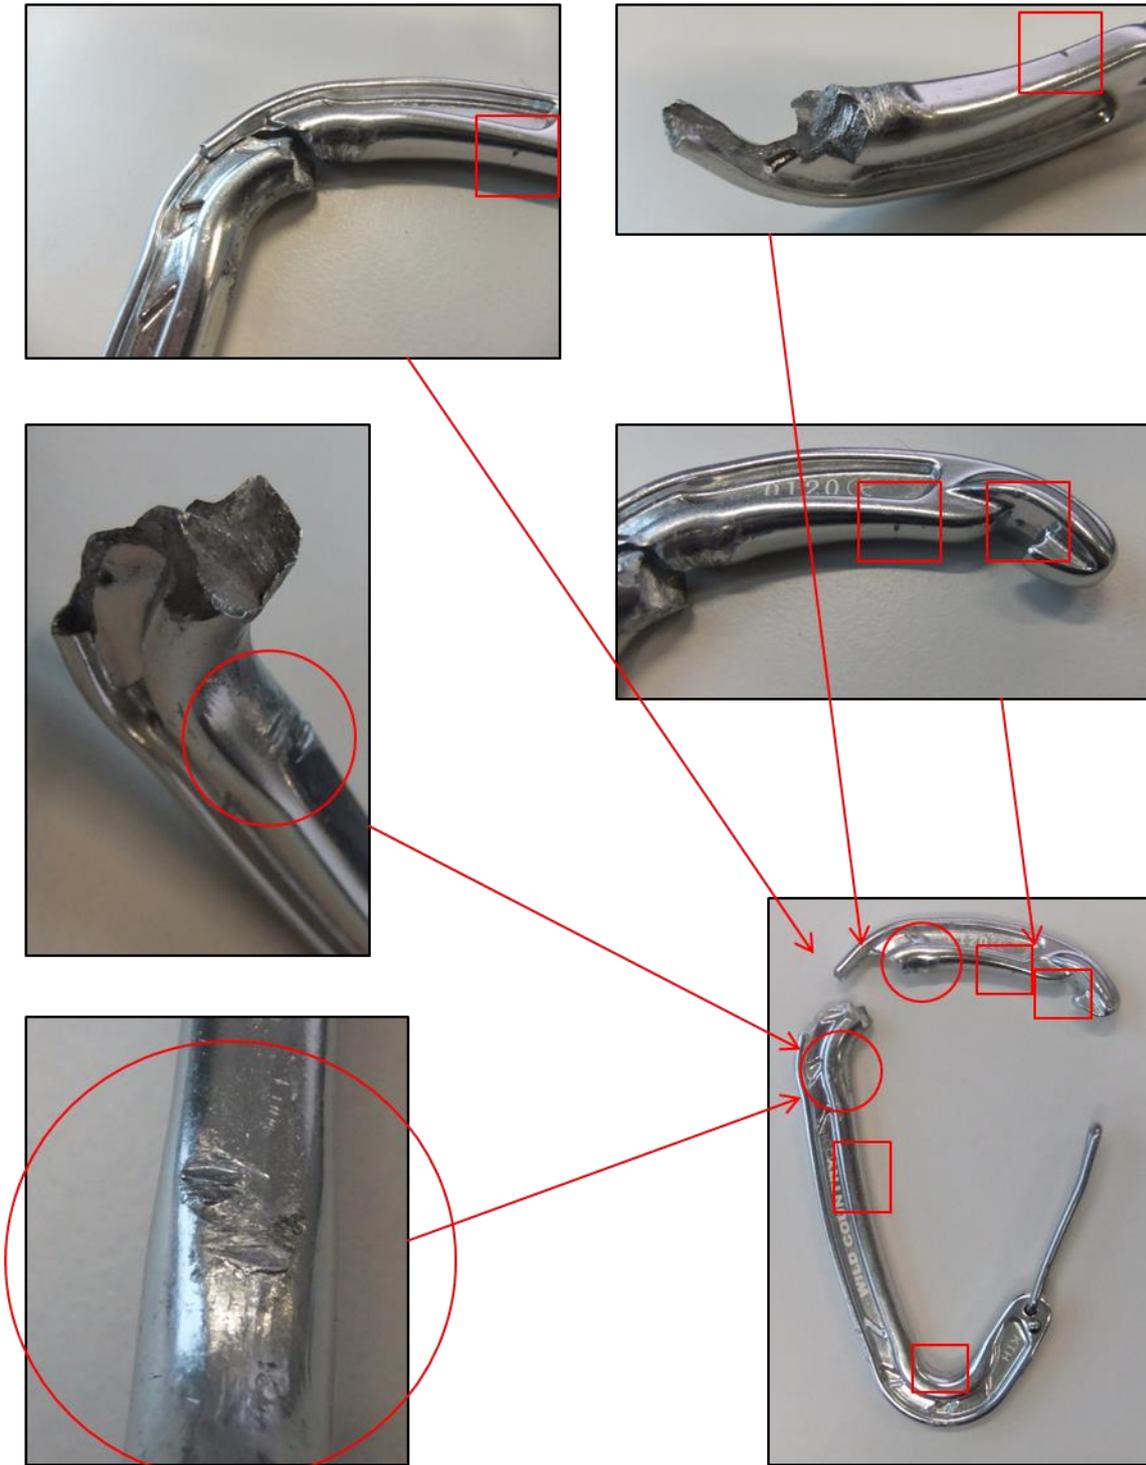
Several regions of the karabiner were noted to display scratches and abrasive pitting, likely due to movement of the karabiner under load whilst attached to a sharp metallic edge, such as a bolt hanger. This hypothesis follows logic because a typical bolt hanger is made of steel, which is much harder than the Aluminium karabiner. Shown in 3, these regions were identified by eye, and are indicated in the image. These were characterised in two magnitudes of severity; i) surface damage shown in squares and ii) up to deep groves in the order of a millimetre depth, likely effecting strength (circled).

Figure 3. Optical images of the whole karabiner with some locations of damage indicated (squared as minor/surface damage and circled as severe).

This case re-iterates the need for careful examination (and retirement when necessary) by the user, when using lightweight equipment. Whilst this karabiner fulfils test standards for a karabiner, the user must be aware of the intended use by design, where in this case, I believe the product is an all-purpose product, not specifically designed to meet the rigours of repeated falls/heavy wear that occur during working or red-point attempts that may occur when sport climbing.

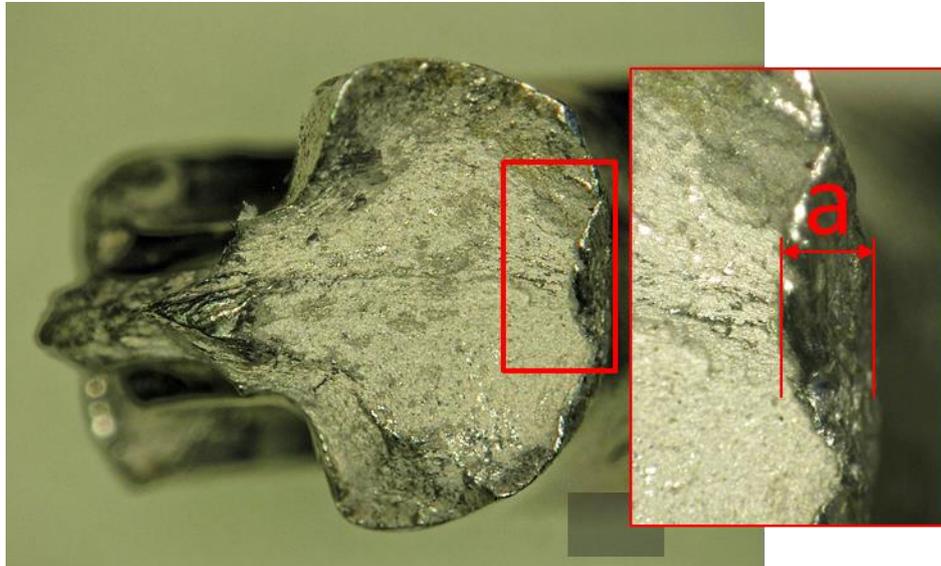
The broken fracture surface was examined to determine the initial crack length (presumably from bolt damage on the karabiner) and a value of approximately 0.53-0.56 mm was obtained for the centre of the damaged region, see Figure 4. Due to the rough nature of the surface, it was difficult to be sure of the exact initial crack length.

Figure 4. Optical image of the fracture surface.

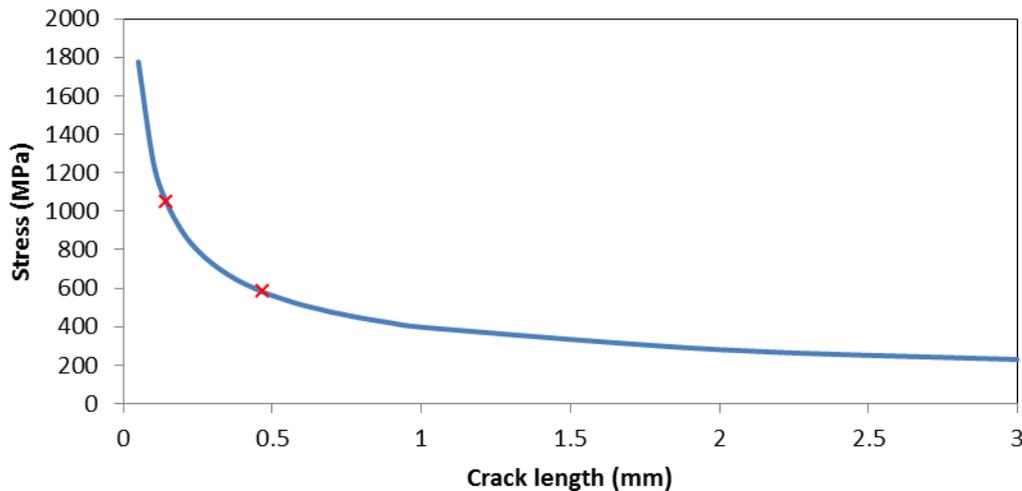
We may determine the stress, σ, as a function of crack length, a, shown in Figure 6. The graph shows the stress as a function of crack length with two points identified, 1,048 MPa for x = 45 mm, a = 0.14 mm, and 582 MPa for x = 25 mm, a = 0.47 mm. Although an estimate, the calculations suggest that the circa 0.55 mm starter crack, and the identified

loading condition would be sufficiently large, to result in fracture of the WC Nitro karabiner. Such a depth of crack, based on the grooves that have been observed, seems reasonable.

Figure 6. Graph to show the crack length dependence of stress. Two cases: $x = 45$ mm and $x = 25$ mm identified as red crosses.
