## TECHNICAL COMMITTEE REPORT TCM 19/01

### Failed Fixe Lower-off Incident Ref. 07/19/O.PYB

#### SUMMARY

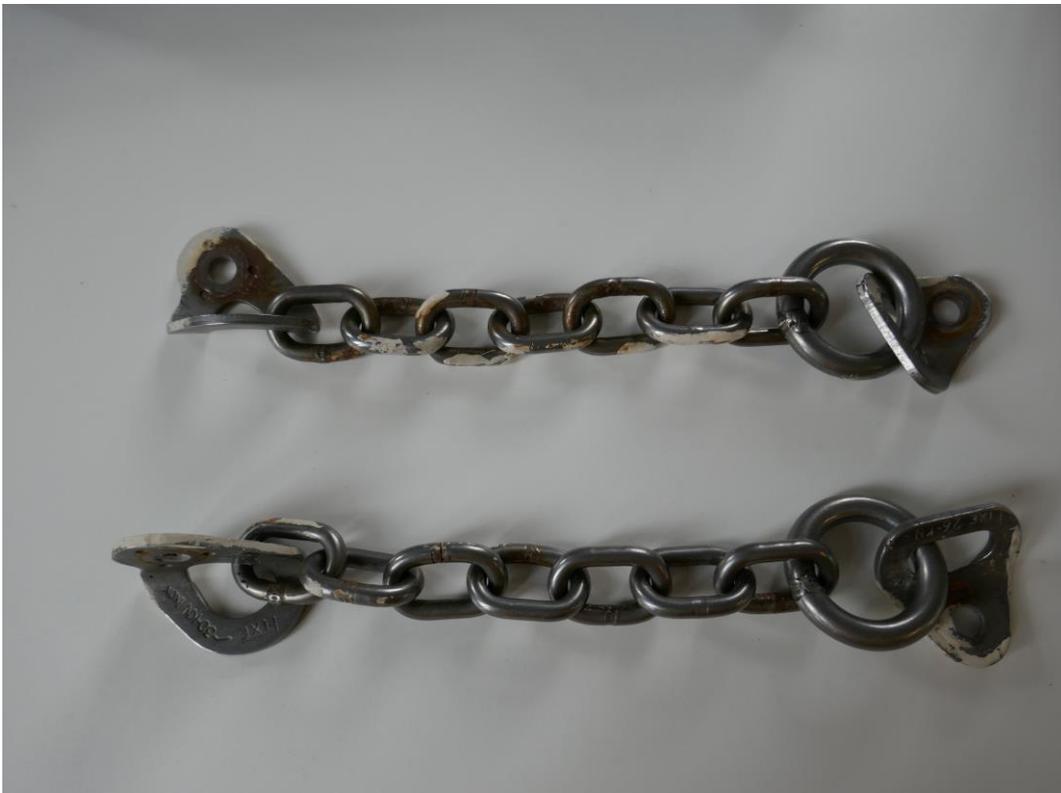
*Figure1: Two chain lower-off units as received*

The two units as received are shown in Figure 1 above, with the lower unit the one with the broken chainlink. Manufactured by Fixe, as confirmed by the markings on the plate hangers, there are no batch code markings visible or markings to indicate a date of manufacture. Each unit is marked “INOX” on the top plate hanger, suggesting that the entire assembly is manufactured from AISI 304 or its equivalent.

Some paint was visible on both units, along with what appears to be superficial surface corrosion mostly located around the chainlink welds. Inspection of the failed unit found a clearly broken link through the weld, on the third link down from the top plate hanger, seen in Figure 2.

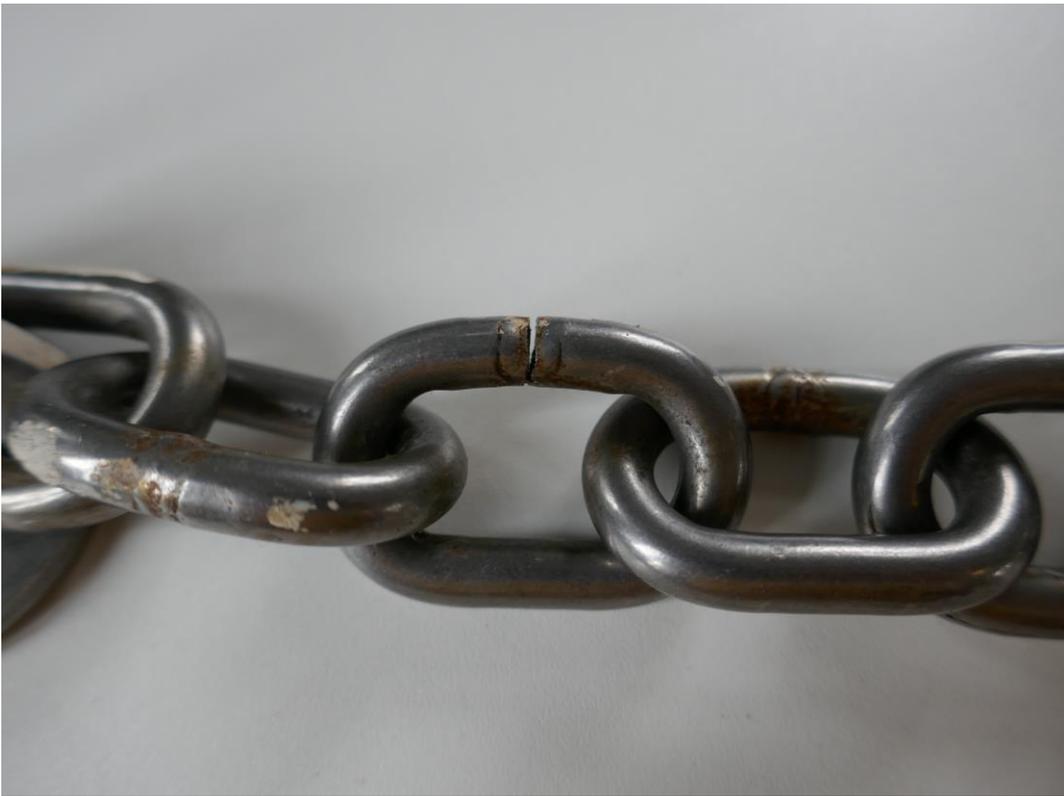
*Figure2: Third link broken through the weld*

Regarding the broken chainlink shown in Figure 2, the estimated loads produced using the test method of whipping a chain of karabiners are modest compared to the service load expected of this product. Further metallurgical analysis would be required to determine the cause of the failure.

Given the location installed in, SCC is unlikely to be a cause in the failure of the chainlink. Further analysis including metallurgical analysis of the fracture surface and compositional analysis of the chain material are required to determine a cause of the failure.

Figure 2 shows that it breaks without elastic deformation. It is not done when it breaks as a mechanical stress.

It is recommended that further analysis is undertaken, either by an independent test house, or by sending both units to the UIAA Safety Commission, who are already investigating other reported failures of chainlinks in Fixe anchor units.

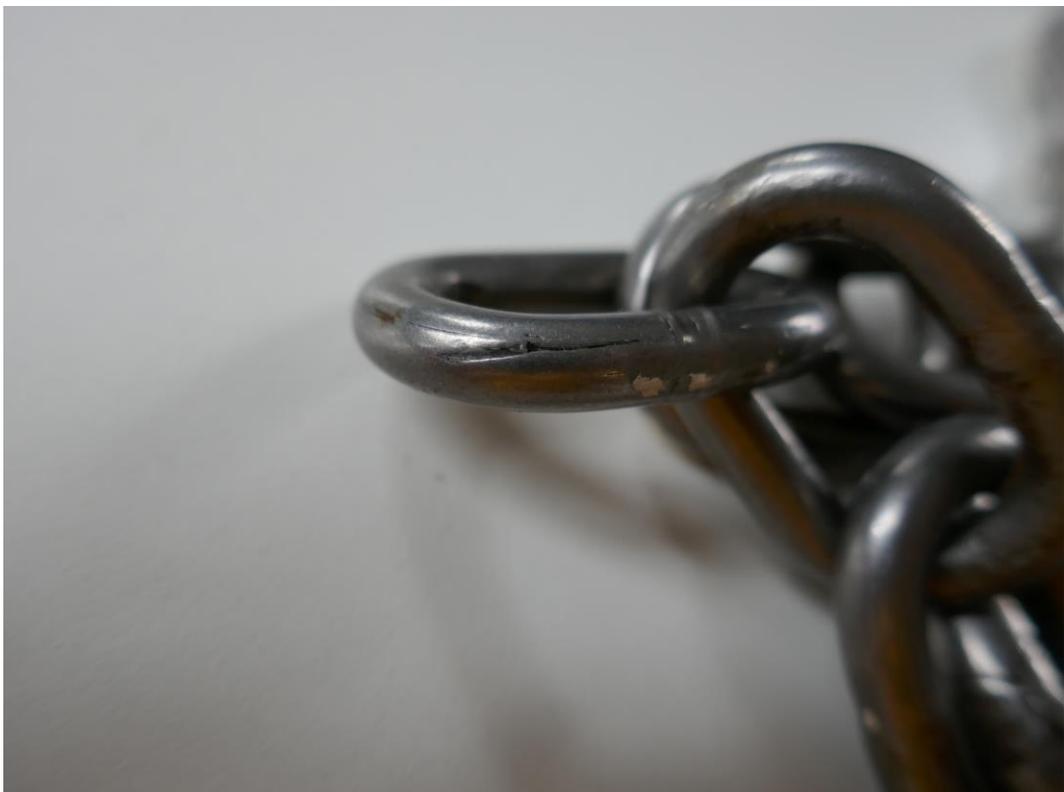
*Figure3: Gross defect in one of the chainlinks of the failed unit*

Figure 3 shows the first defect noted, found on the 5<sup>th</sup> link down from the top plate hanger. This defect continues around entire structure of the link. Figure 4 shows four defects of increasing size and similar shape to each other found on the link which connects the chain to the top plate hanger.

Both gross material defects would have been expected to have been detected during one of the following procedures:

Multiple gross material defects in the chain assembly were found and do not appear to have been detected by the manufacturer's QA system. Tensile testing would be required in order to determine if these defects prevent the unit from meeting the required standards for chain or climbing wall anchors.

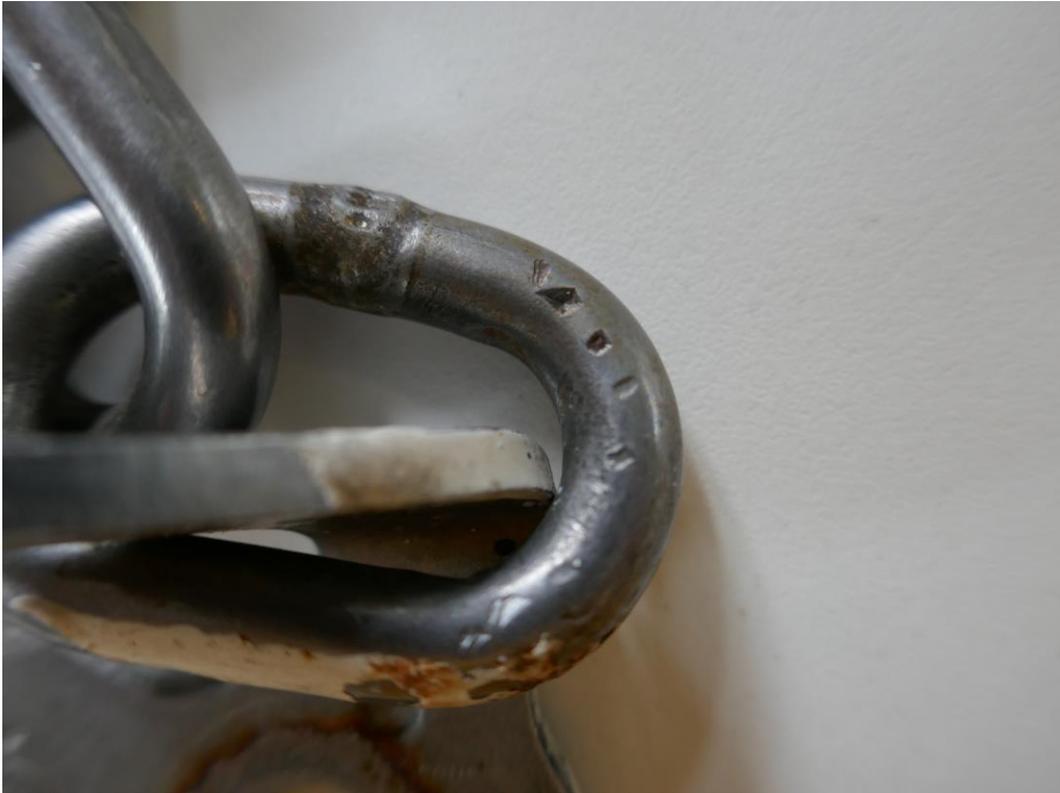
*Figure4: Defects noted on link connected to the top plate hanger*

It is highly improbable that we deliver a product as the figure 4 and you not return to us the first day as a quality defect.

We never had any devolution as it is showed in this figure 4.

Then if the anchor has 4 year installed probably it happen during the installation-service. Today we not have detailed information but if the anchor is not properly installed and the chain is load in different directions then could be marked with the edge of the plate.

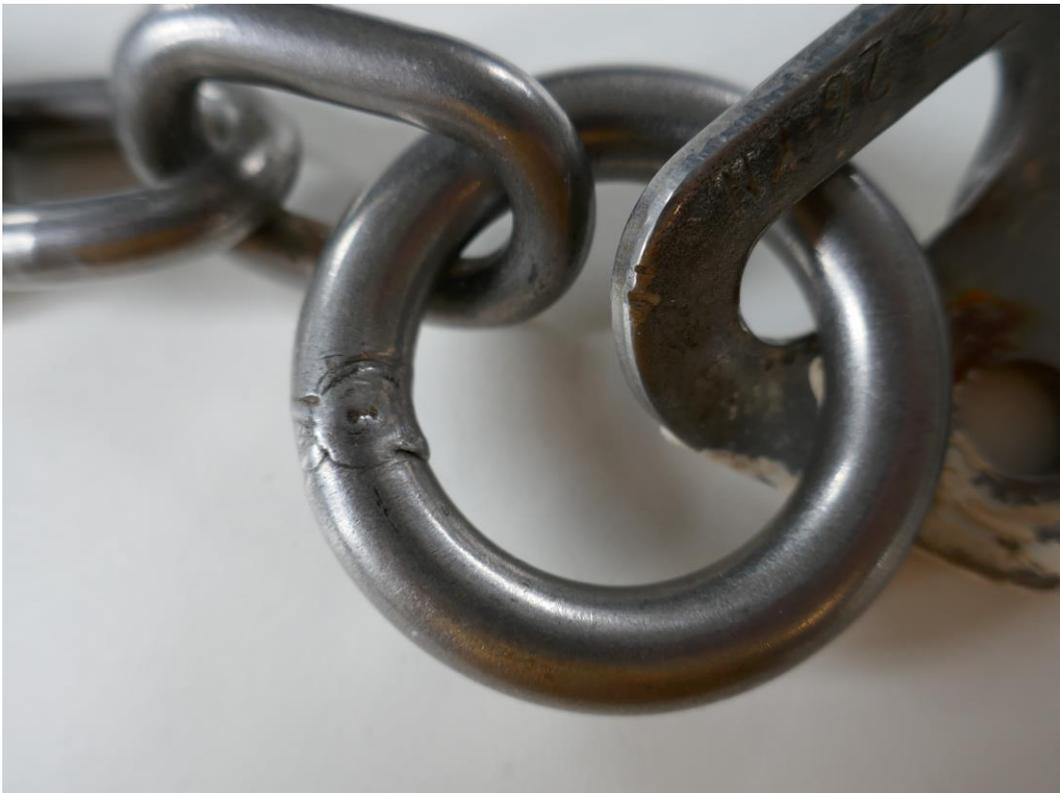
*Figure5: Rough finish on welded ring*

In addition, the inspection of the failed unit found that the finish of some welds including on the circular ring looked rough and rather untidy, with a visible gap between the weld material and the main body, as seen in Figure 5.

Concern over the quality and surface finish of the welding on the circular rings, and the welds in general on both units received were noted.

In case of the figure 5 the weld could not be considered with rough finish. In any case, if on initial inspection or any year inspection it would be found and reported, could be replaced by FIXE as guaranty
