TECHNICAL COMMITTEE NOTE TCN 18/02

Rock Anchor Testing – Sea Cliffs

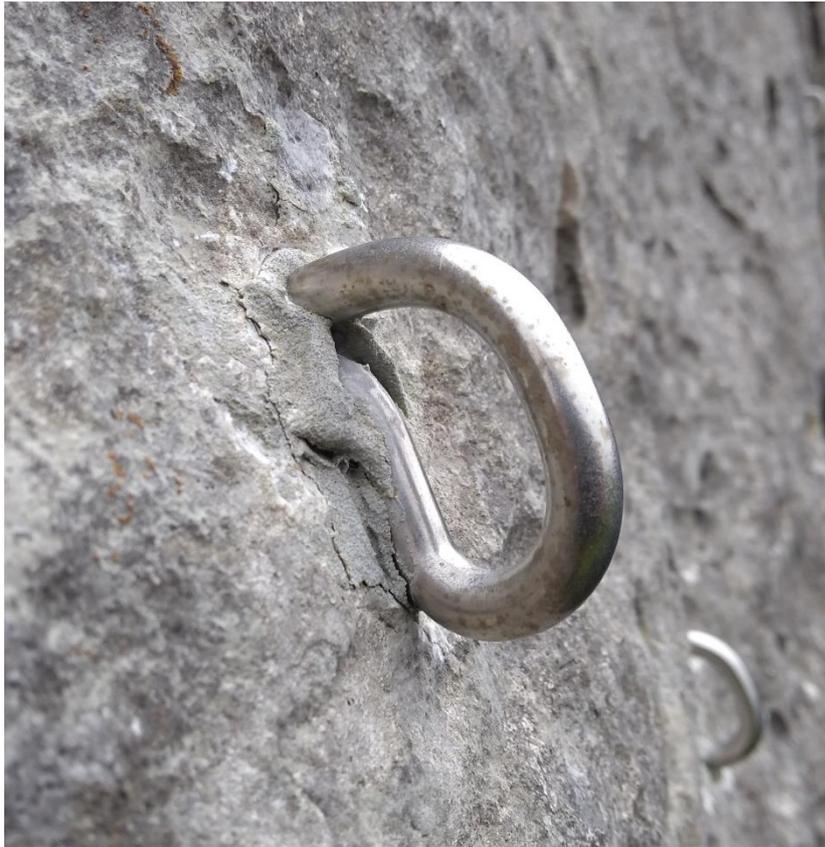
All of the anchors tested passed the load test without failure. Visual inspection found all anchors to look in good condition, with the exception of the AISI 316 Bolt Products (A) anchors at site 2, which all had some surface staining present. Similar staining was not noted at site 1. Of note was that staining was visible on the side of the anchor orientated towards the sea rather than the landward side.

AISI 316 anchor at site 2 showing visible staining, shot taken facing landwards.

The results so far are as expected. The main point of interest is that staining of the AISI 316 anchors appears to be present at the location which would be assumed to be less hostile. Damp, salty air from sea spray carried by the wind will often be present at site 2, but at site 1 there should be much greater amounts of chloride ions present due to the immediate proximity of the water. It is possible that at site 1 any deposited ions are washed off regularly and the actual amount of chloride ions on the surface is less than at site 2, but this is speculation.

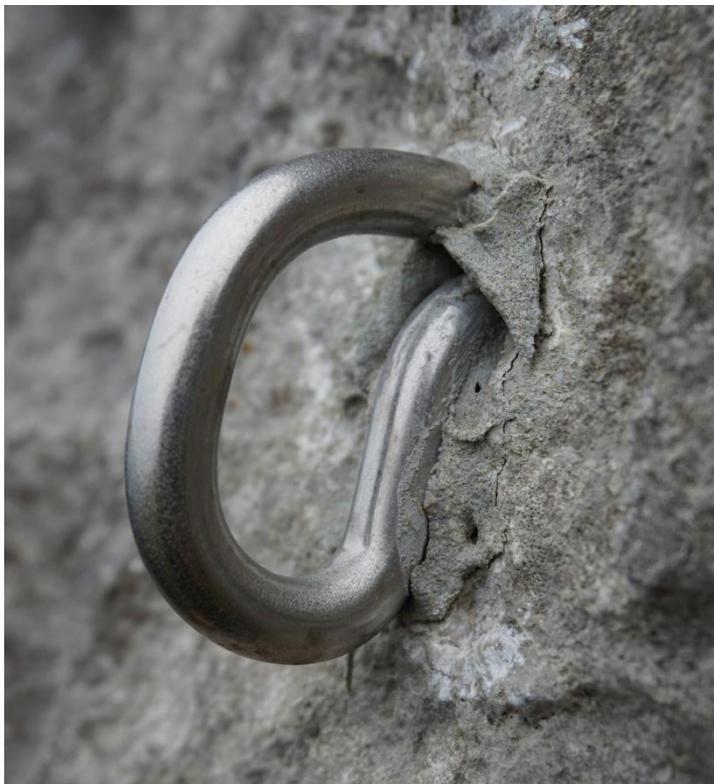
Same anchor as above with no staining, viewed facing seawards.

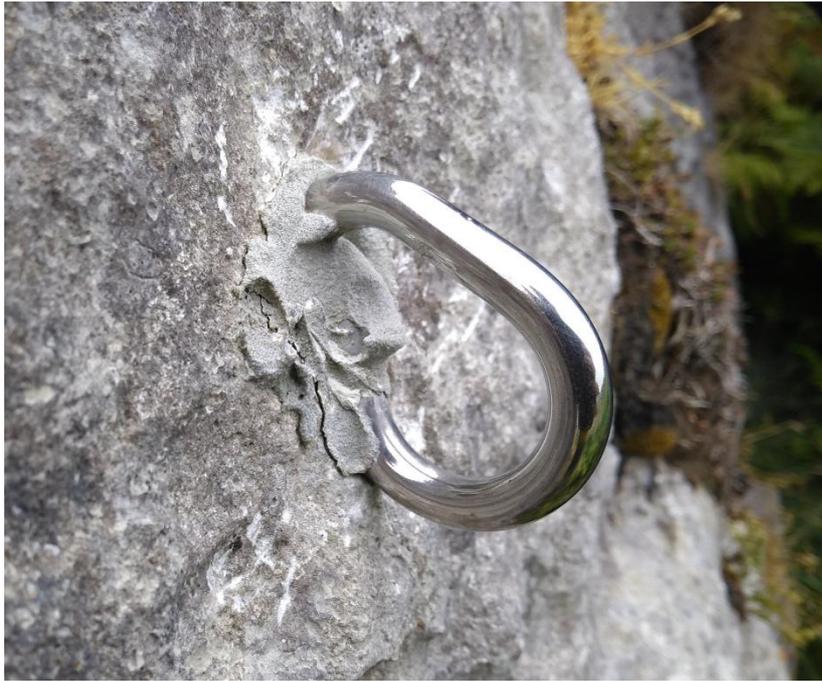
1.4462 anchor at site 2.

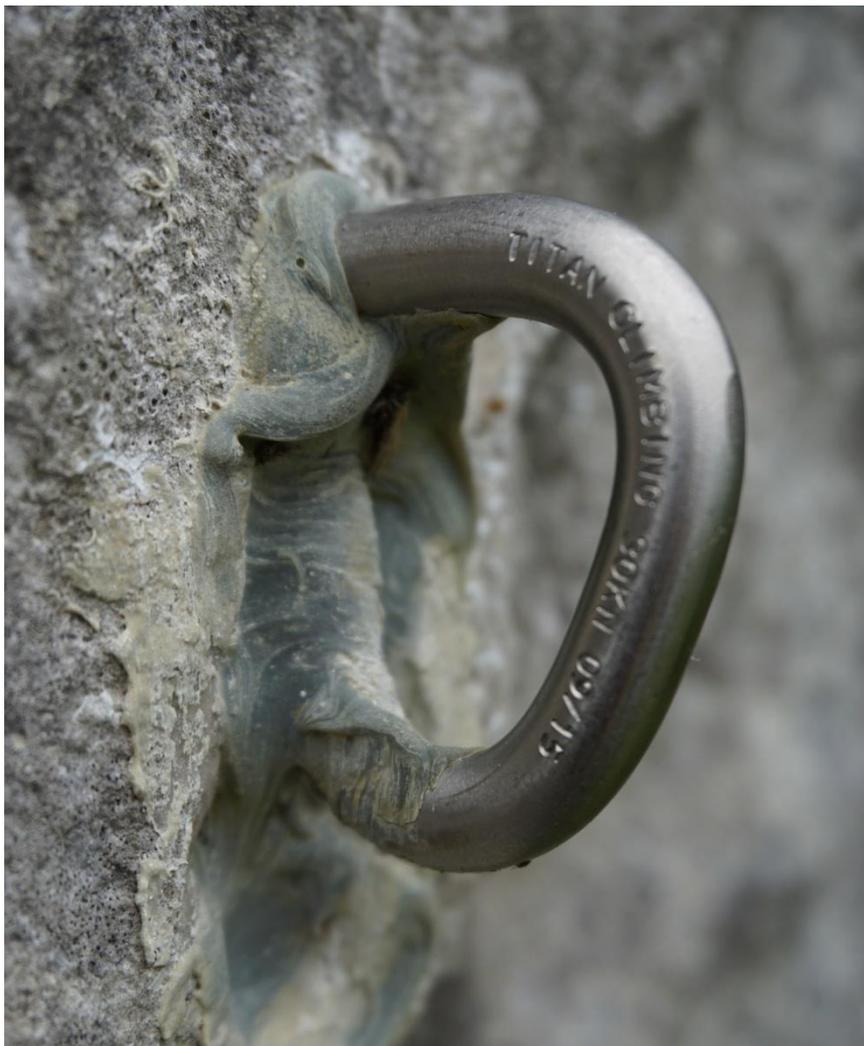
Titanium anchor at site 2.
