BRITISH MOUNTAINEERING COUNCIL

TECHNICAL COMMITTEE MEMORANDUM TCM 13/02

Broken Wild Country Wildwire karabiner Incident Ref. IR08/13/C.PAT

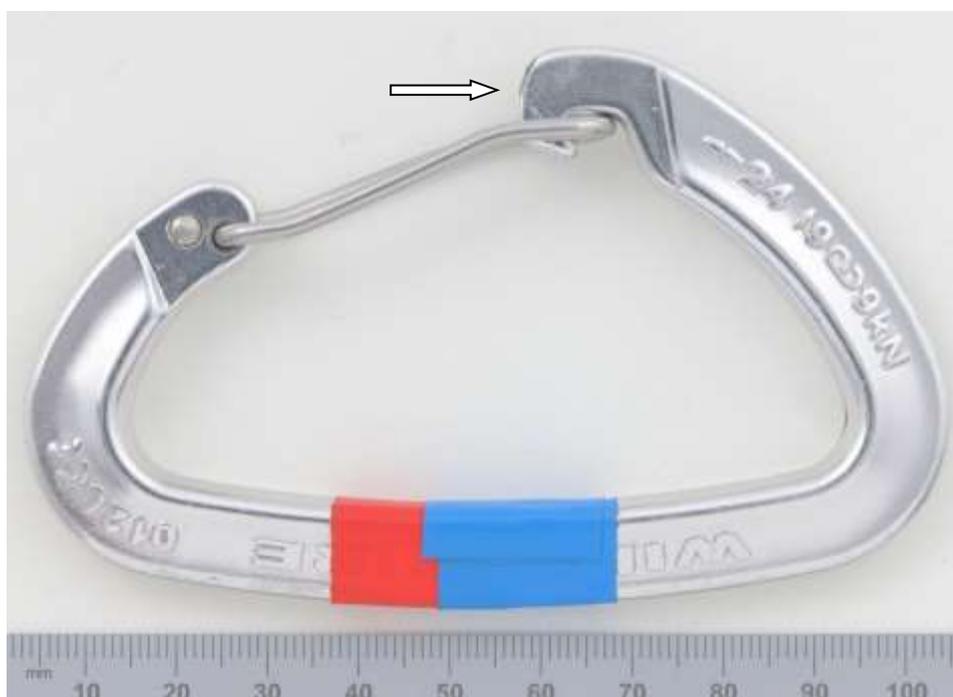
The broken karabiner arrived at TWI in late December 2013. From a cursory visual examination (Figure 1 and Figure 2), the karabiner appears to be in a safe condition, because the failure surface (arrowed) was located at the very tip of the nose, and therefore did not affect the ability of the snap gate to snap shut. Moreover, there was no indication of sharp edges likely to have caused injury after the failure. A closeup view of the nose region (Figure 3) shows the failed area from the side, along with some surface scratches, whilst Figure 4 shows the failure surface in more detail.

Figure 1 General view of karabiner from side 1 (D012291_001)

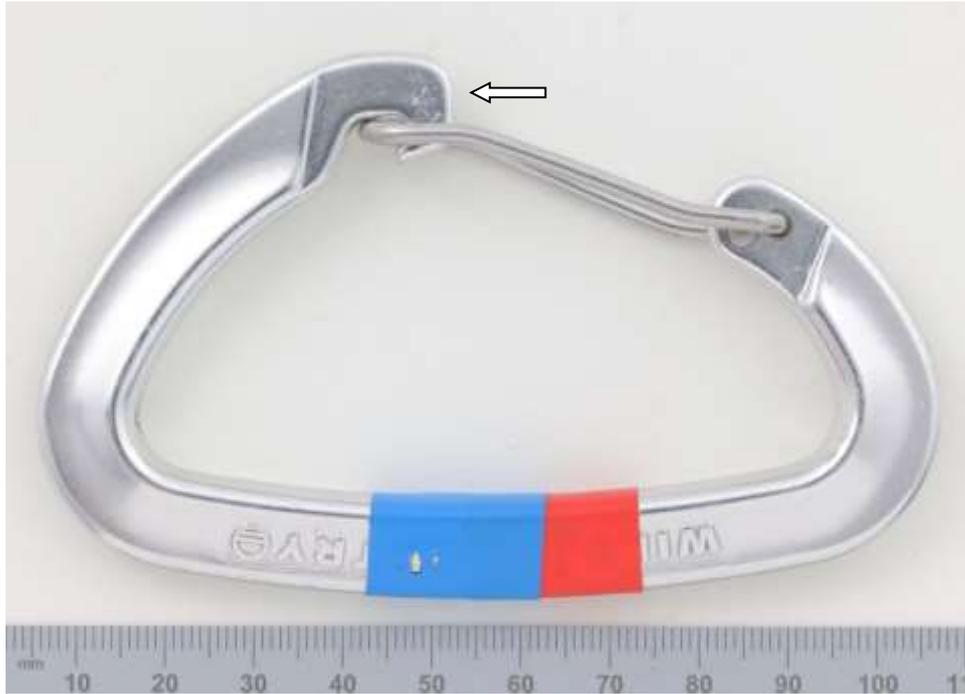
Figure 2 General view of karabiner from side 2 (D012291_002)

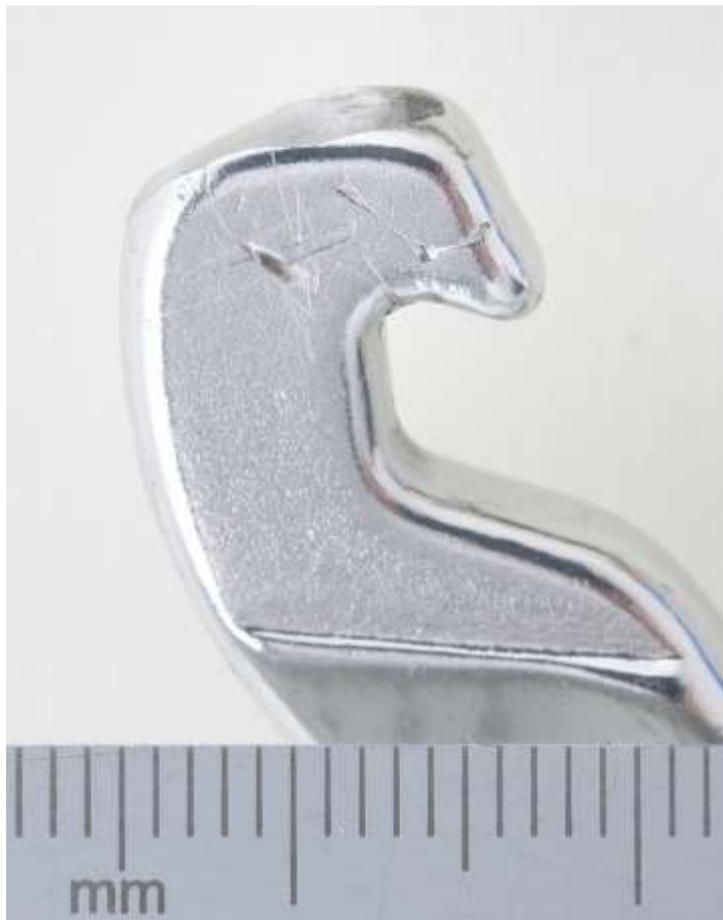
Figure 3 Closeup of failed area from the side (D012291_003)

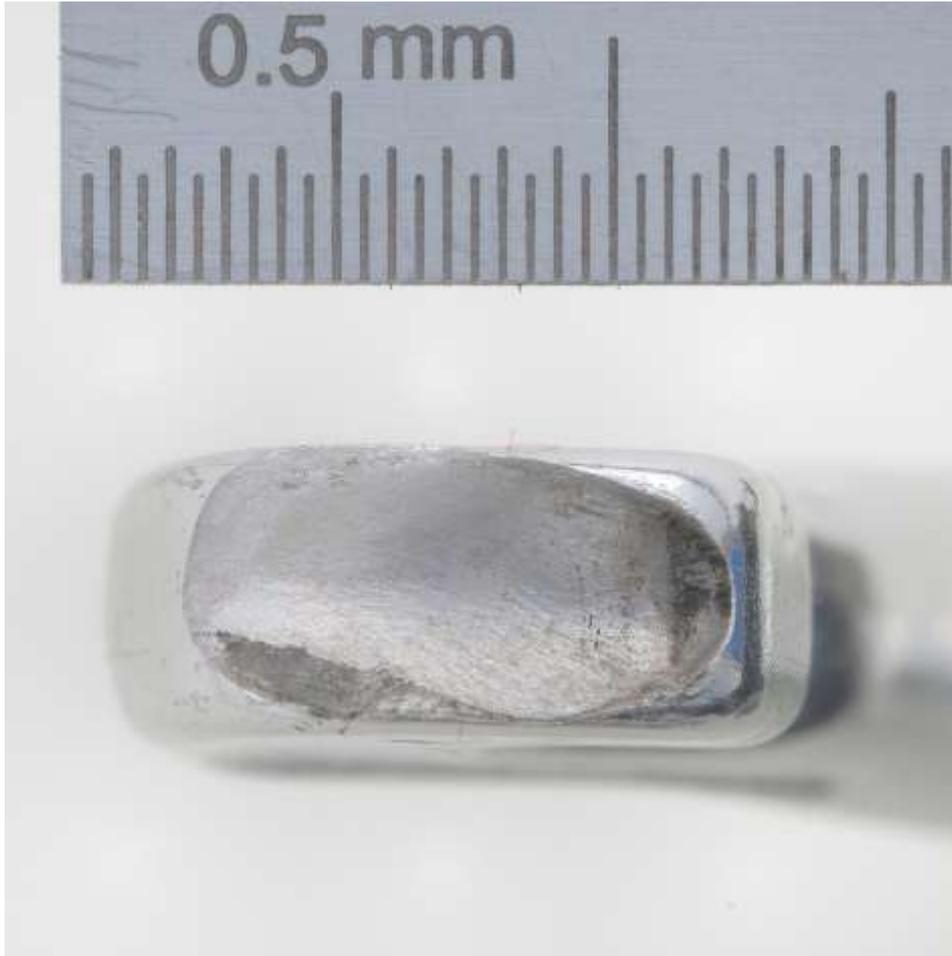
Figure 4 Closeup of failure surface (D012291_006)

The failure surface as viewed by SEM (Figure 5) is seen to be smooth and rather featureless; the change in contrast apparent in Figure 4 (associated with a change in angle of the failure surface) can not be seen. No obvious cracking mechanism was seen.

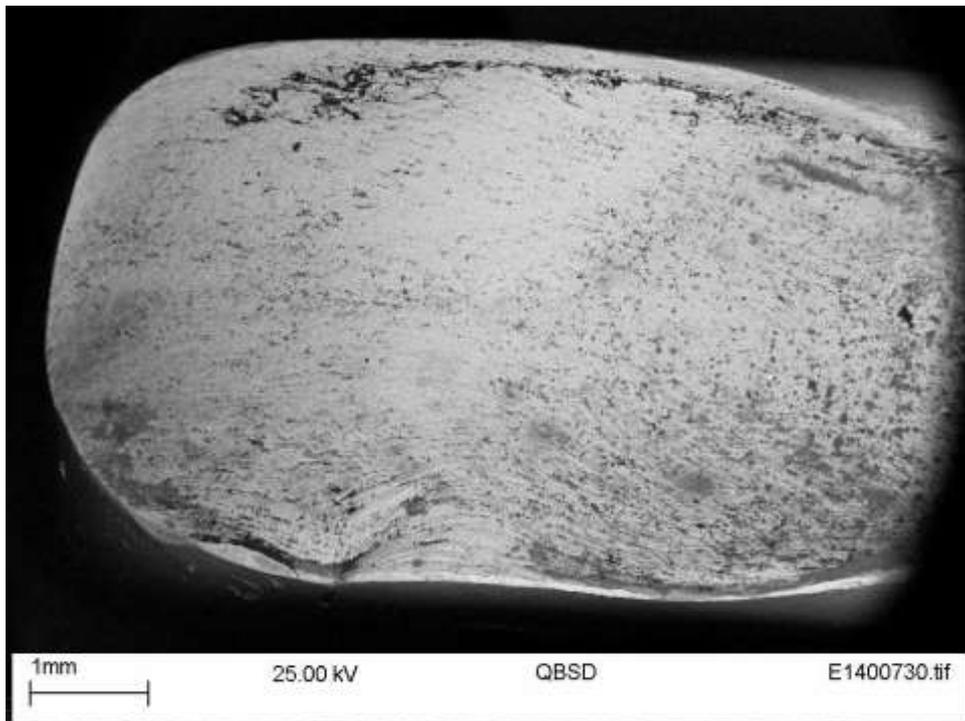
Figure 5 SEM image of failure surface

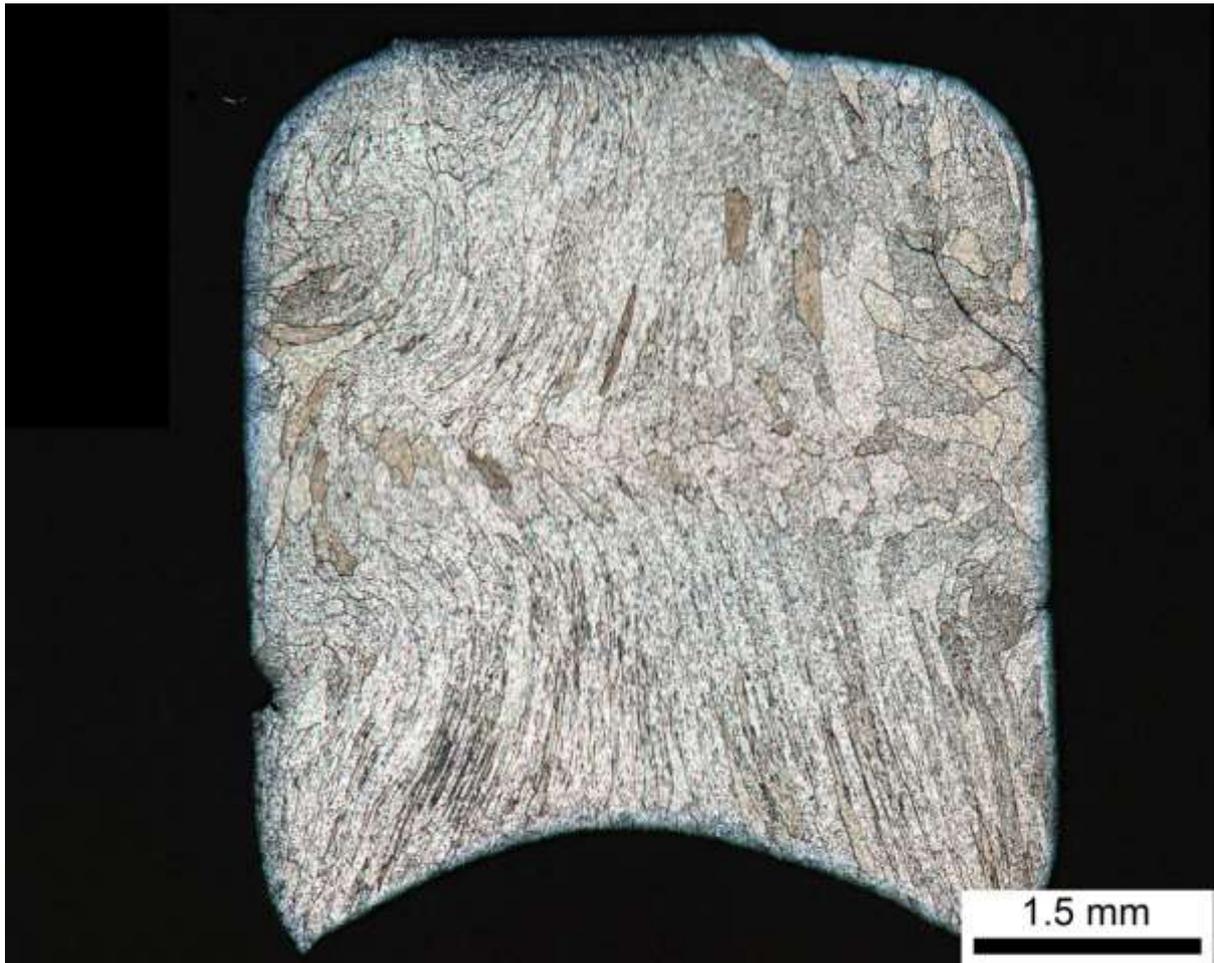
Figure 6 Section through failure surface, etched in Keller's reagent and examined by light microscopy (DM2500M2014-02-21-15-25-37)

The cross-section through the failure surface (Figure 6) reveals the microstructure of the alloy and what appears to be a relatively shallow forging flaw (top right of figure). The concave edge towards the bottom of the image corresponds to the failure surface, and again no obvious cracking mechanism (eg stress corrosion) is seen.

The most likely explanation for this failure appears to be that it was associated with a forging flaw that extended almost through-thickness and opened up during use (light impact associated with clipping).

It is recommended that this failure should be referred to Wild Country for comment, as it may not be an isolated case.
