TECHNICAL COMMITTEEMEMORANDUM TCM 09/01

Beal rope, snapped
Incident Ref. 09/01/B.HEU

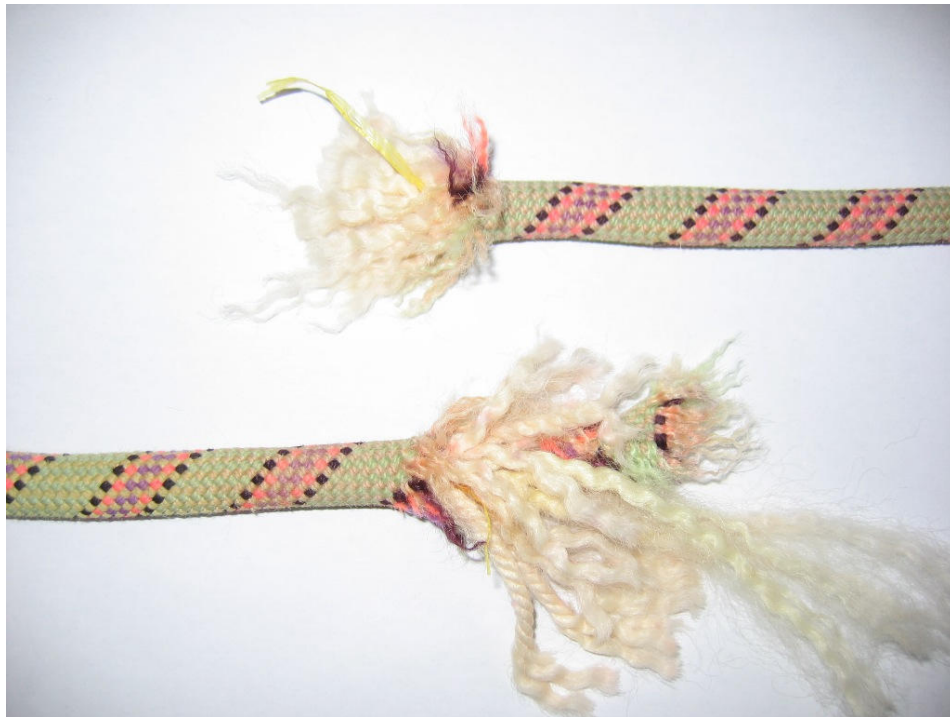
Subsequent inspection and testing of the rope found that it had been contaminated by a strong acid. It is likely that this contamination lead to the deterioration and eventual breakage of the rope under a relatively small load.

Inspection of the area where the rope had snapped found that the sheath was badly stained in this area. The break itself had occurred over a fairly localised area. The ruptured core strands appeared to be stained a yellow colour. Around the break, some of the exposed core strands could be pulled apart easily by hand.

The rope snapped because of degradation of the polyamide material used in its construction. This degradation was caused by contamination of the rope by a strong acid from an unknown source. This incident could have been avoided if the rope had not been contaminated in the first place, but also if the user had been aware that the discolouration was caused by a dangerous chemical as opposed to chalk dust.

The owner and user of the rope should check that locations where the rope may have been stored or transported are not contaminated. The remaining 50m of rope should be inspected carefully for any evidence of discolouration and change in texture, and discarded if found to be present.
