**TECHNICAL COMMITTEEMEMORANDUM TCM 09/01**

**Beal rope, snapped**  
Incident Ref. 09/01/B.HEU

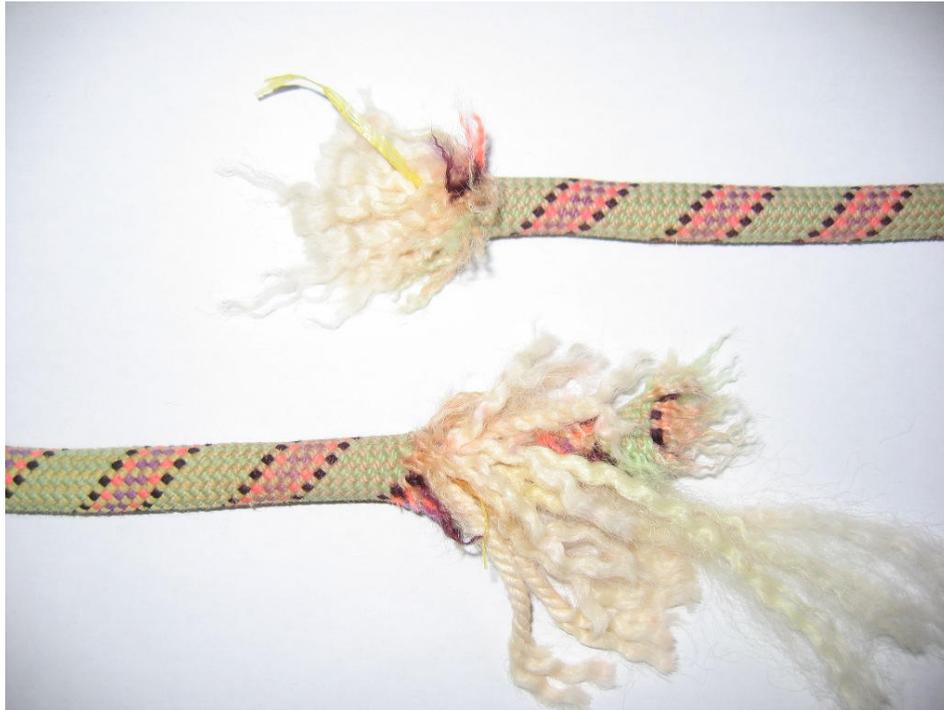
A Beal single rope was being used at an indoor wall. Whilst a climber was being lowered to the ground upon completing a route, the rope snapped. Fortunately no injuries were sustained by the climber.

Subsequent inspection and testing of the rope found that it had been contaminated by a strong acid. It is likely that this contamination lead to the deterioration and eventual breakage of the rope under a relatively small load.
