### TECHNICAL COMMITTEE MEMORANDUM TCM 09/02

#### Wild Country Technical Friend 3 - Broken in Fall Incident Ref. 08/09/L.HOU

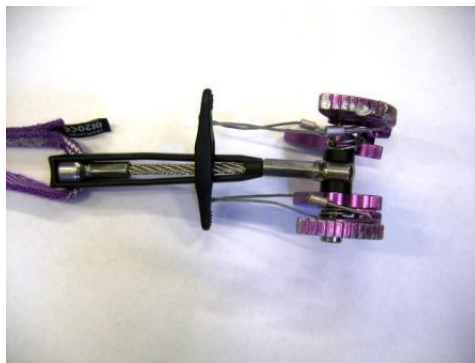
A Wild Country Technical Friend failed in a fall. It is concluded that this was due to the device being twisted because of the choice of placement.

As can be seen on the photographs the stem of the Friend is bent (Figs 1 & 2) and one of the inner cams has sheared away from the axle (Figs 3 & 4). The surfaces of two of the cams are badly damaged (Figs 4 & 5) and all the trigger wires are bent. From an examination of the undamaged stem and the tape sling it appears that the Friend was in good condition before the fall and had not been used a great amount.

It is obvious from the damage to the Friend that it was twisted when loaded in the fall. From the damage and distortion that the device has suffered, it is also clear that it was subjected to a significant load before it failed. We have seen this type of failure before and a comprehensive examination was carried out at the time and a Technical Committee Report written (Ref 1). The conclusions from this earlier report were that the camming device failed due to twisting and there was no evidence of any manufacturing defects. These devices are not designed to withstand the torsional forces involved if subjected to twisting in a fall so it is considered that the cause of failure was a poor choice of placement. However it is recognised that often there is no alternative placement (this was certainly the case in the incident described in Ref 1) so unfortunately Mr Houbart was unlucky.

It is concluded that this Friend failed due to torsional overload caused by a placement where the direction of loading in the fall was not along the axis of the device.

In view of the fact that we have seen this type of failure before it is recommended that a short article be prepared for Summit Magazine to point out that camming devices should be placed with care so that the force in a fall will be along the axis and any twisting of the device is likely to cause failure.
