BRITISH MOUNTAINEERING COUNCIL

TECHNICAL COMMITTEE MEMORANDUM TCM 10/03

Cracked Black Diamond Helmet

Incident ref: 02/10/F.KNO

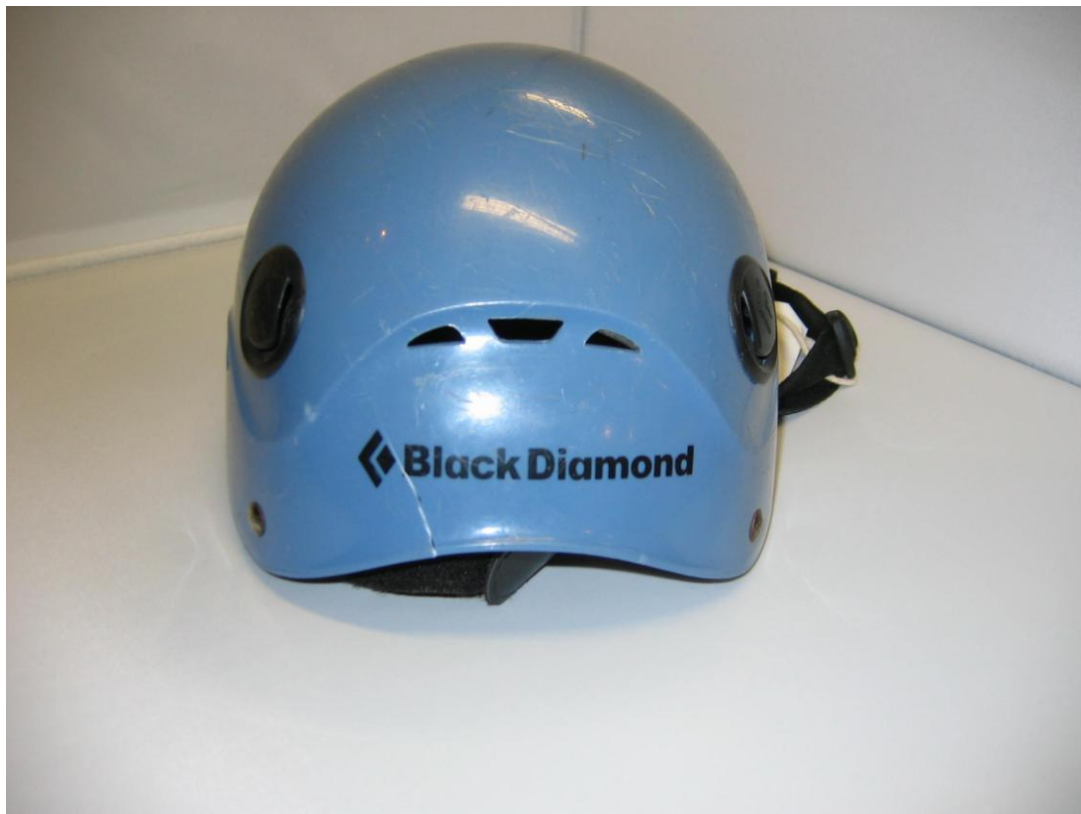
Figure 1: Black Diamond 'Half Dome'

A Black Diamond helmet was received exhibiting a crack on the back rim. This was reported to have been found when removing the helmet from a rucksack prior to a climb. No injuries were sustained as a result of this breakage.

Following inspection of various areas of damage on the helmet, it is believed a significant crushing force was exerted across the sides of the helmet, causing bending of the back rim and the subsequent cracking observed.
