BRITISH MOUNTAINEERING COUNCIL

TECHNICAL COMMITTEE MEMORANDUM TCM 07/02

HB Screwgate Karabiners, worn Incident Ref. 07/02/C.WIL

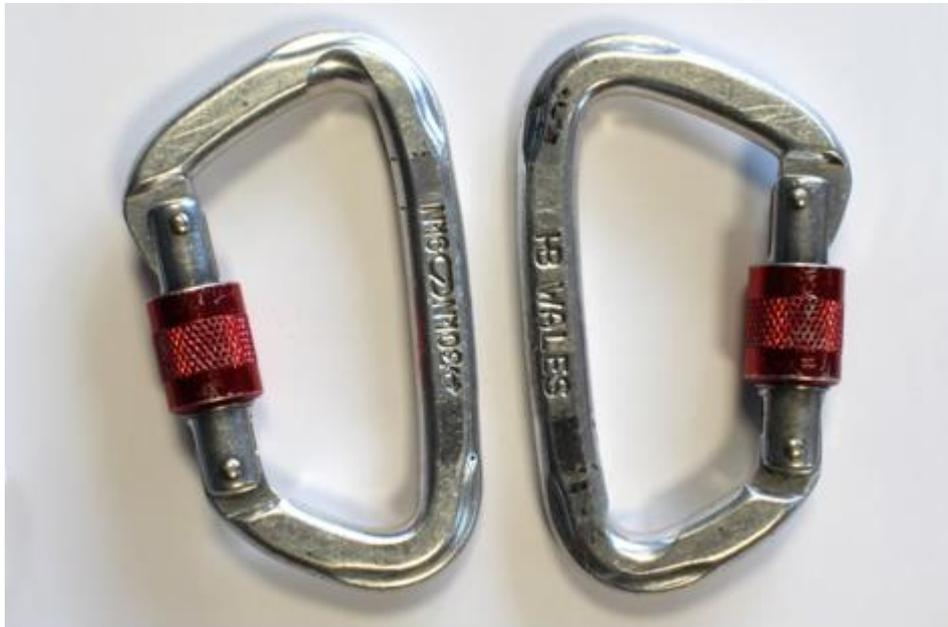
The result of this investigation indicates that, although severely worn the degree of wear on these karabiners is most probably due to the water and grit carried on the surface of the rope creating an abrasive action on the karabiners resulting in the wear seen.
