TECHNICAL COMMITTEE MEMORANDUM TCM 14/02

Wild Country Nitro Snap Gate Failure

Incident Ref. 05/14/C.SCH

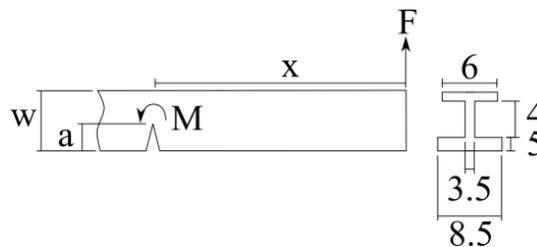
Figure 5. Part geometry of the WC Nitro karabiner that was studied.

Where M is the moment (F.z), z being the moment arm (i.e. distance from crack to loading point on the karabiner), y is the distance to the neutral axis and I is the moment of inertia. Two cases were considered, x = 45 mm, where the nose is assumed to be jammed and create a moment on the karabiner, or x = 25 mm, an arbitrary distance along the karabiner.
